August 9, 2008

**HOME INSPECTION REPORT**  
**Street Address Removed**  
**Bloomfield, NJ**

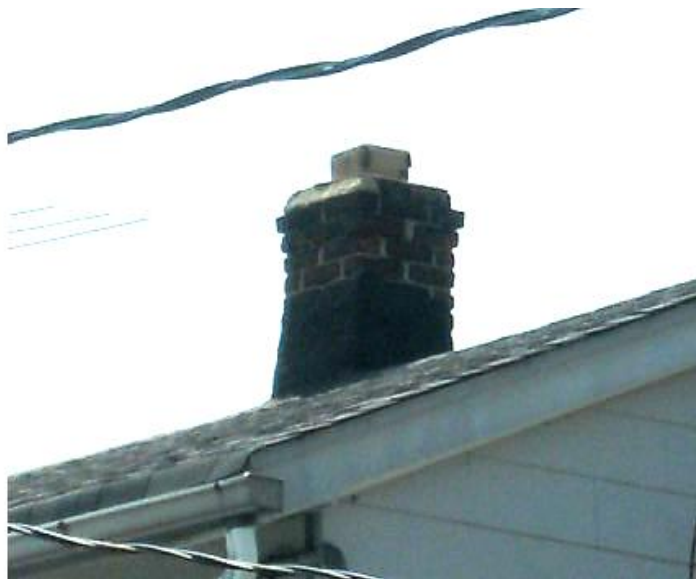
- **Chimney flashings appear to be older, and are heavily tarred and roughly patched. Leakage can occur around older chimney flashings.**
- **Significant cracks, loose and missing sections of mortar were seen on the upper sections of the chimney.**

Chimney has heavily tarred and patched flashings and needs repair

- **The National Fire Protection Association and the National Chimney Sweep Guild recommend that, due to the advanced age or other conditions, a Level-2 Inspection of the chimney and internal components be done to rule out hidden potential safety defects.**
- **Have a qualified chimney contractor clean, service and repair the chimney as required to assure long term function and safety.**
- **Have a qualified chimney contractor seal the out of use atmospheric damper plate for closed.**

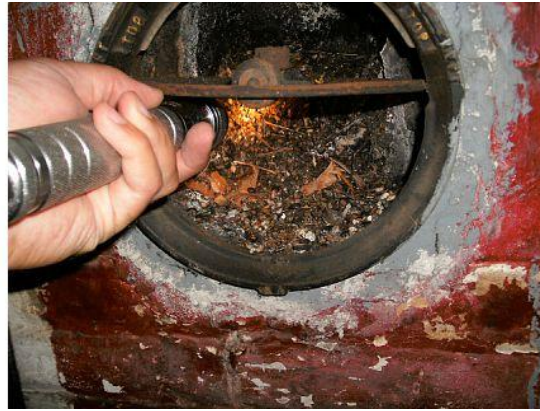
- **An old, out of use atmospheric damper plate is present on the chimney. This plate is no longer necessary, and should be sealed closed, however a significant amount of debris was seen in the chimney flue through this plate. This could be a hazard, as chimney fires or flue blockage could result.**

Significant debris in the chimney flue

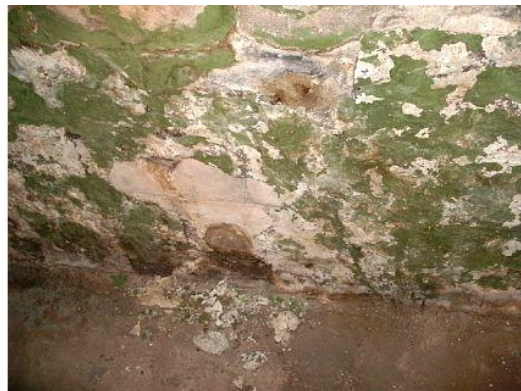
- **The interior masonry coating on the foundation walls is loose and crumbling in many areas. This is likely due to water penetration over time.**

Crumbling interior foundation wall coating

- **Signs of prior water entry were found to be present along most areas of foundation walls. The interior coating on the foundation is crumbling, most likely as a result of water penetration through the foundation wall.**
- **Lack of maintenance to the roof drain system is likely contributing to water entry into the basement.**

- **See Roof Drainage section – make sure water around the home is well controlled, with no accumulation near the base of the home. This can help reduce the possibility of foundation settlement in the future.**
- **Have a qualified mason repair the deteriorated sections of the foundation wall coating.**

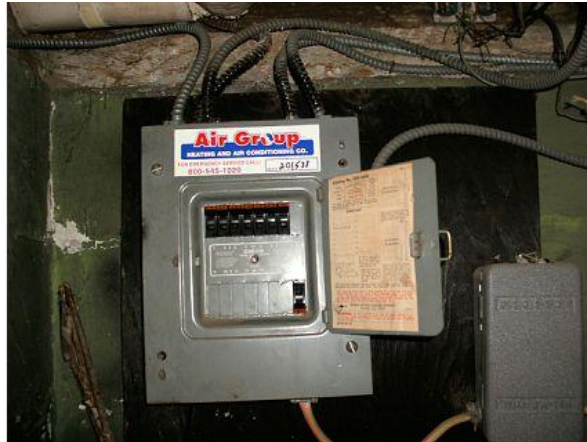
- **This circuit breaker panel is a Federal Pacific brand panel, with StaBlok circuit breakers. These brands of equipment are known to be defective. The circuit breakers may not trip reliably when overloaded. This can result in wiring damage and fires.**
- **The breaker panel has no single main breaker. This is no longer considered to be acceptable.**

Federal Pacific breaker panel – known to be unsafe

- **Have a licensed electrician ensure that adequate grounding is provided to the electrical system.**
- **Have a licensed electrician replace the Federal Pacific breaker panel and StaBlok breakers with a new, approved breaker panel and new breakers.**
- **Have a licensed electrician install functional GFCI electrical outlets in all wet areas that lack them, including kitchens, bathrooms and exterior outlets.**

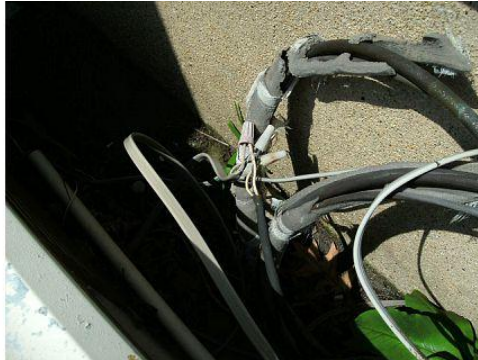
- **The compressor is older and has significant wear.**
- **The AC compressor is now past the end of its designed service life. Continued reliable operation cannot be assured.**
- **Electrical connections to the compressor are exposed on the exterior, and in the basement stair area. This is a hazard.**

Exterior AC connections are exposed

- **Have a licensed electrician evaluate wiring to the AC system, and make repairs as necessary.**
- **Have the AC system serviced annually by an AC technician.**
- **Budget for replacement of AC components in the near future.**

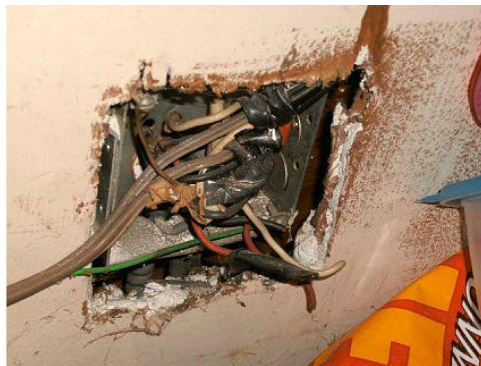
Interior connections are also exposed

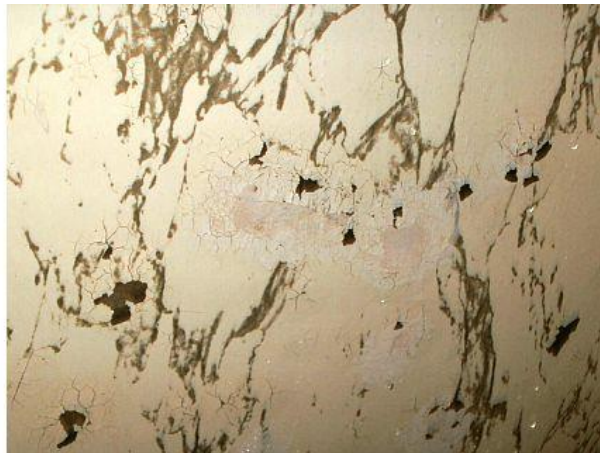
- **All fixtures, faucets and surfaces in the bathroom are very old, and subject to leakage and breakage.**
- **The tub/shower surround material is worn out, with cracking and worn areas. This material is no longer waterproof.**

Worn out tub surround material

- **The bathroom requires complete renovation at this time. All fixtures, faucets and surfaces should be replaced as desired.**
- **Ensure that all plumbing drain pipe connections and any older water supply valves and connections are replaced at the time of renovation.**
- **See Electrical section.**
