April 8, 2009

HOME INSPECTION REPORT
Street Address Removed
Cranford, NJ

The following are the findings of a **Home Inspection** of the subject property done on April 4, 2009. This report is for the use of *client names removed*.

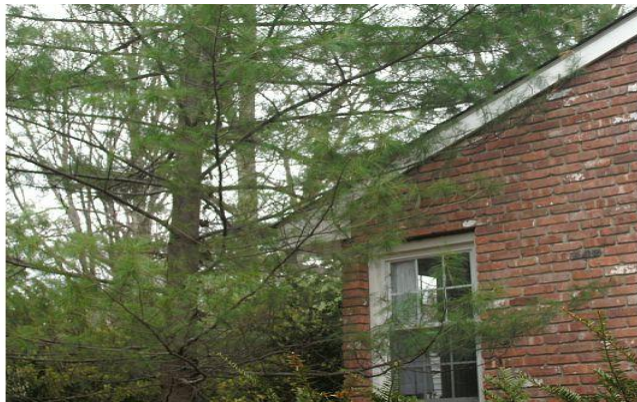
- **Overgrown vegetation is close to or in contact with the sides of the house of some areas.**
- **Trees or tree branches adversely impacting the home, particularly a tree at the left rear which is in contact with the roof.**

Tree at the left rear

The above conditions are conducive to wood destroying insect entry, and can cause damage to the roof and siding.

- **Have trees, shrubs and plants trimmed back or removed so they are no longer in contact with or overhanging the home.**

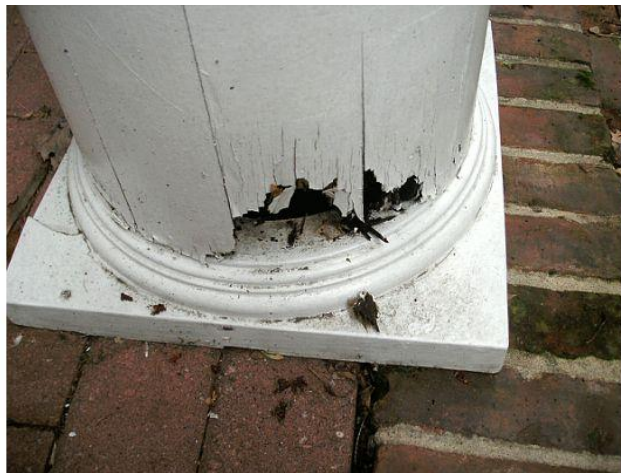
- **Wood columns on the front entry area are damage by exposure to water and rot.**

Water damage to the base of wood columns

- **See Structural Supports section.**
- **Have water and insect damaged wood columns and trim repaired or replaced.**
- **Have metal trim on front bay windows modified or repaired to allow water to drain off.**
- **See Roof Drainage System section.**

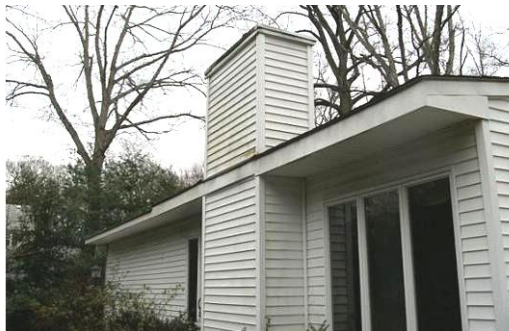
- **Gutters / downspouts are not present on most sections of the roof. This is allowing water to accumulate at the base of the home, which can cause water entry into the basement / crawlspace and/or foundation settlement (both of which have occurred at the left front).**

No rain gutters present on most sections of the roof

Inadequate or defective roof drainage systems, if present, can lead to water entry into the basement, foundation damage and/or roof leakage.

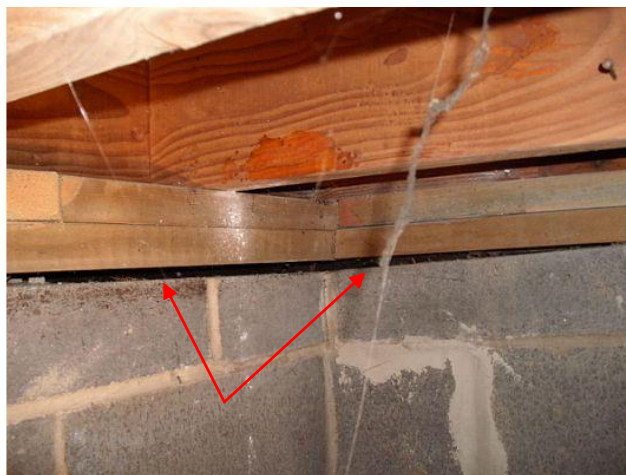
- **Significant carpenter ant damage is present to a floor joist end at the left front.**
- **There is a gap between the wood sill plate and the left front corner of the foundation. This appears to be a result of the foundation settlement previously described.**

Gap between foundation and sill plate

- **Have a qualified contractor familiar with wood destroying insect damage repair further evaluate and repair wood destroying insect damage to the left front floor joist and to the exterior garage wall between the two doors.**

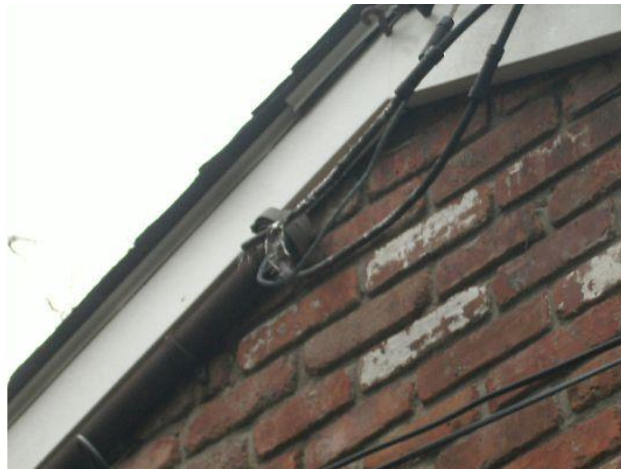
Service entrance location: Overhead. **The service entrance cable is older and insulation is frayed.**

Frayed insulation on electrical service entrance cable

- **Have a licensed electrician replace the obsolete breaker panel with a new, modern breaker panel with a single main breaker. Replace the frayed overhead feed cable and upgrade total service capacity to 200 amperes in the process of these replacements.**
- **Have a licensed electrician install functional GFCI electrical receptacles in all wet areas of the home including kitchens and bathrooms that lack them.**
- **Have a licensed electrician ensure that all open junction boxes / exposed electrical connections are appropriately covered / enclosed so that all hazards are eliminated**

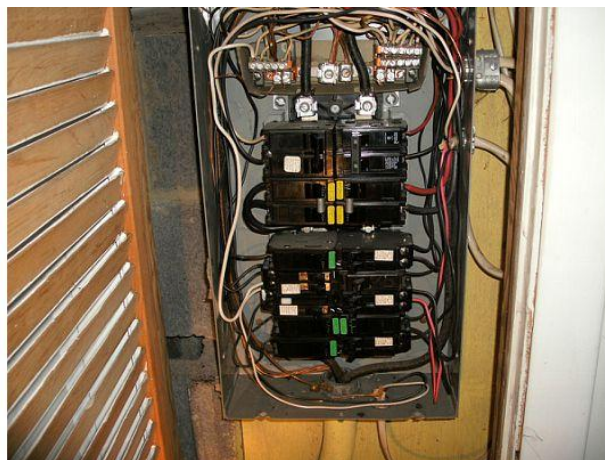
- **This breaker panel is an older type and does not have a single main breaker to disconnect service. This type of panel is no longer considered to be appropriate for a single family detached residence.**

Obsolete breaker panel with no single main breaker

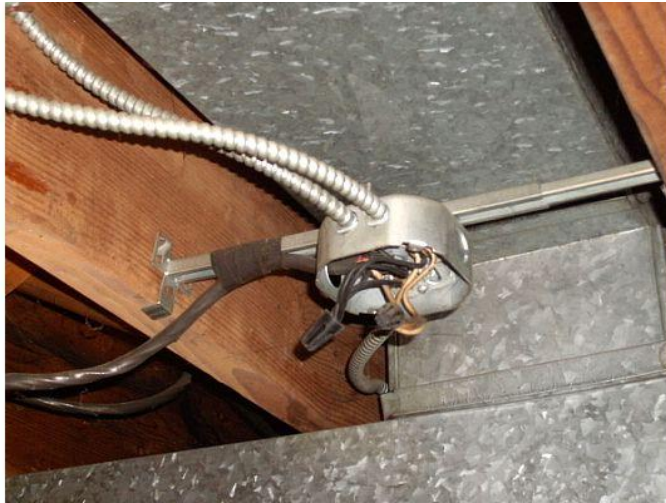
- **Many uncovered and open electrical junction boxes / exposed electrical connections are present in the basement and elsewhere in the home. This is a hazard.**

Open junction box with exposed wiring

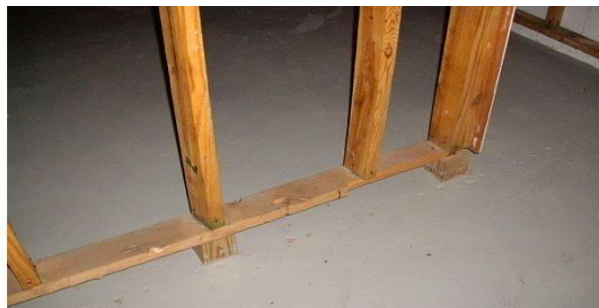
- **Signs of prior water entry were found to be present. The basement appears to have been flooded in the past. Where basement flooding has occurred in the past, experience shows that the possibility of repeat flooding in the future is increased.**
- **Wood stud walls are now raised and supported on wood blocks, presumably to reduce damage from the possibility of future flooding.**

Wood stud wall is raised off basement floor by blocks

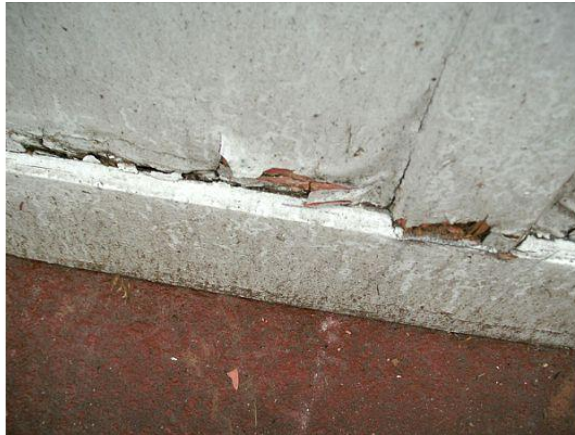
The doors have significant water / weather related deterioration on some of the panels.

Damage to garage door

- **Have a qualified garage door contractor repair or replace doors as necessary, and adjust height of garage door opener sensors to be 6 inches from the floor or lower.**
- **See Structural Supports section and the separate wood destroying insect report.**
