April 8, 2009

HOME INSPECTION REPORT

Street Address Removed

Cranford, NJ

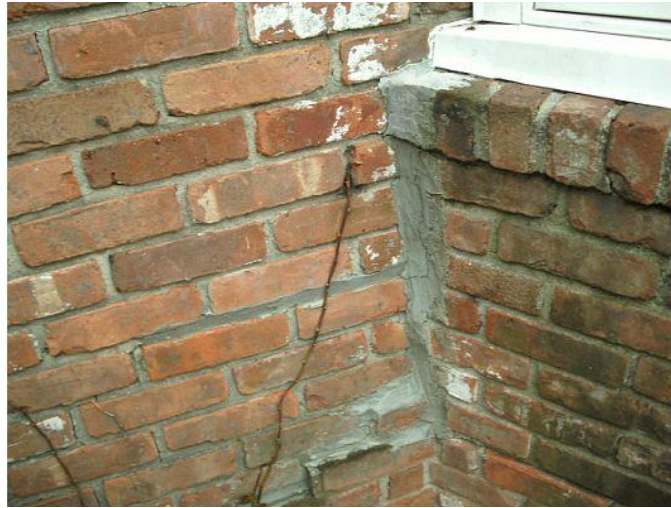
- Most sections of facades are functional.
- **The brick facade at the left front corner has cracked. This has been caused by settlement of the foundation in this area (see Structural Supports section).**

Patched cracks at the left front brick facade

- **Have a qualified contractor familiar with foundation wall repairs further evaluate and reinforce or adequately repair the settled section of the masonry foundation at the left front corner. This may require excavation to expose the foundation footing and underpinning of the footing as may be determined by the further specialist evaluation.**

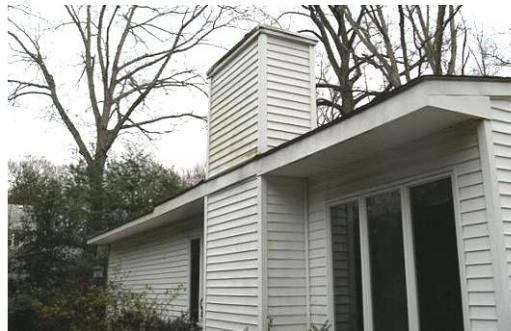
- **Gutters / downspouts are not present on most sections of the roof. This is allowing water to accumulate at the base of the home, which can cause water entry into the basement / crawlspace and/or foundation settlement (both of which have occurred at the left front).**

No rain gutters present on most sections of the roof

Inadequate or defective roof drainage systems, if present, can lead to water entry into the basement, foundation damage and/or roof leakage.

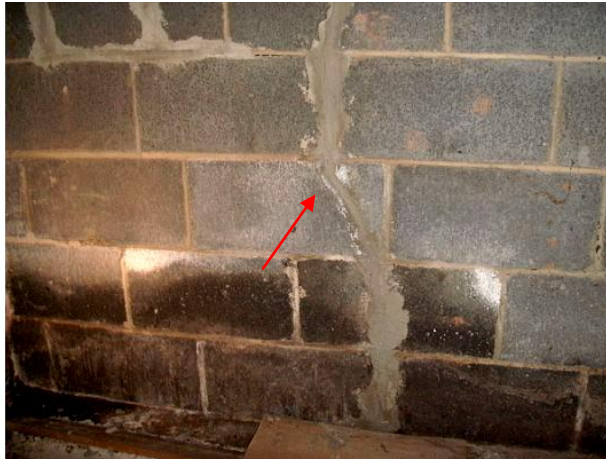
- **Vertical cracks with forward displacement of the foundation wall are present at the left front corner of the home. Cracks of this type that are more than 3/16 inch wide or have other complicating factors such as wall displacement, or evidence of prior patching that has opened up, are not minor, and are considered to be structural defects in need of repair. Our home inspection found foundation wall cracks of the type and degree described above.**
- **Water accumulation at the left front of the home has likely contributed to foundation settlement and cracks.**

Patched cracks in foundation wall visible in crawlspace

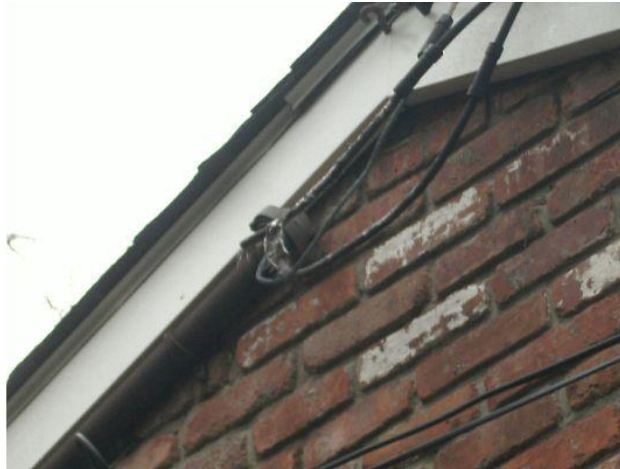
Service entrance location: Overhead. **The service entrance cable is older and insulation is frayed.**

Frayed insulation on electrical service entrance cable

- **Have a licensed electrician replace the obsolete breaker panel with a new, modern breaker panel with a single main breaker. Replace the frayed overhead feed cable and upgrade total service capacity to 200 amperes in the process of these replacements.**
- **Have a licensed electrician install functional GFCI electrical receptacles in all wet areas of the home including kitchens and bathrooms that lack them.**
- **Have a licensed electrician ensure that all open junction boxes / exposed electrical connections are appropriately covered / enclosed so that all hazards are eliminated**

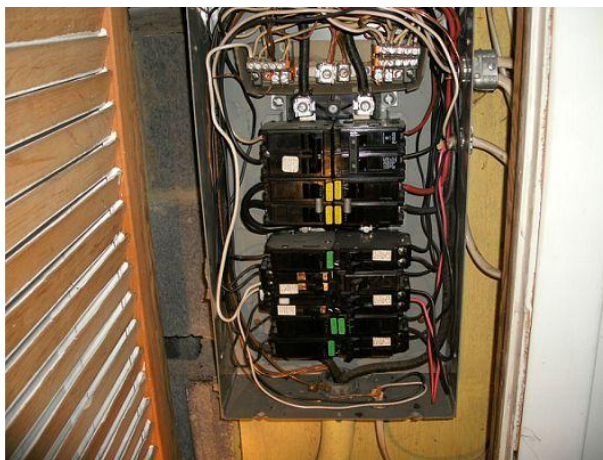
- **This breaker panel is an older type and does not have a single main breaker to disconnect service. This type of panel is no longer considered to be appropriate for a single family detached residence.**

Obsolete breaker panel with no single main breaker
