April 7, 2009

**HOME INSPECTION REPORT**  
**Street Address REMOVED**  
**Millburn, NJ**

The following are the findings of a **Home Inspection** of the subject property done on April 3, 2009. This report is for the use of Client name removed.

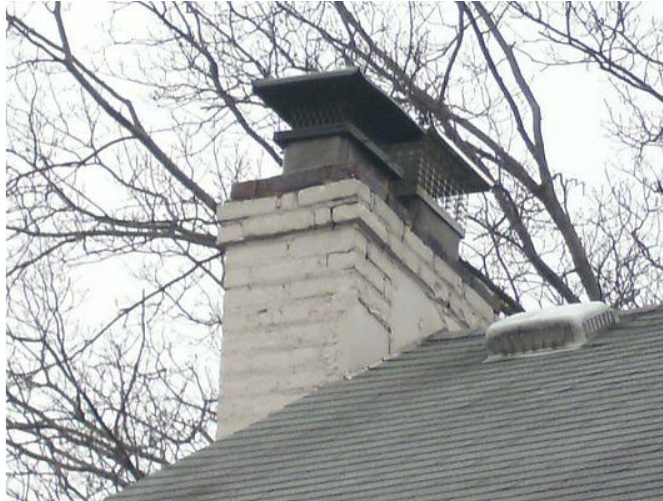
- **Chimney flashings appear to be older. Leakage is more likely to occur around older chimney flashings.**
- **Some cracks, loose and missing sections of mortar were seen on the upper sections of the chimney. Lack of maintenance to the exterior and exterior damage strongly suggests the presence of interior hidden defects.**

Deteriorated masonry joints at top of chimney

- **The chimney is now very old, and the possibility of interior flue blockage or other interior damage is significantly increased.**

- **The National Fire Protection Association and the National Chimney Sweep Guild recommend that, due to the advanced age or other conditions, a Level-2 Inspection of the chimney and internal components be done to rule out hidden potential safety defects, and we recommend this as well.**
- **Have a qualified chimney contractor service or repair the chimney(s) as required to assure long term function and safety.**

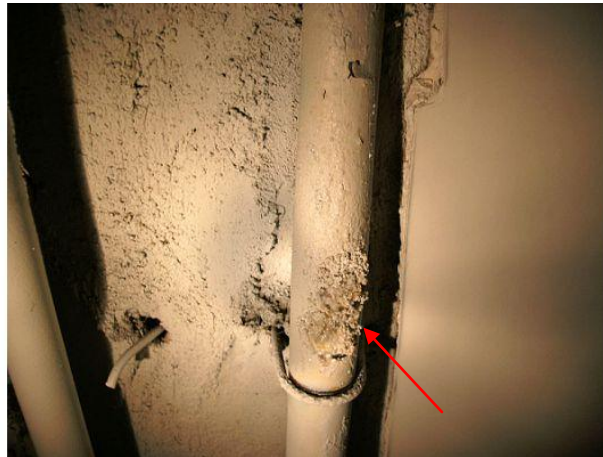
- **Some sections of brass pipe in the garage are leaking.**

Leaking brass water pipe found in garage

- it as necessary to assure reliable function.
- **Have a plumber replace the sections of brass water pipe that are leaking as soon as possible. We also recommend that *all* remaining sections of old brass pipe be replaced, whether currently leaking or not to avoid further damage from water pipe leaks in the near future.**
  - **Have a plumber replace any older water supply shutoff valves with corrosion or leakage.**
  - **To determine the true condition of the waste and drain pipes we recommend that a plumber inspect them internally using a specialized video camera.**

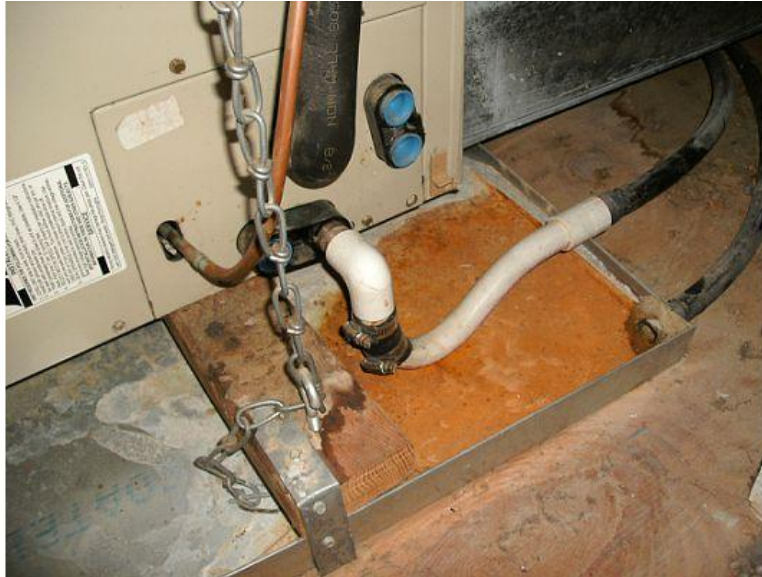
Physical Condition (Exterior Only): **Significant Corrosion present in condensate drain overflow pan, indicating likely condensate drainage leak or clog. This can result in significant water damage.**

Corrosion in AC condensate drainage pan

AC Condensate Drain Overflow Pan: Present. **Corrosion is present in the pan (see above).**

- **Have the AC system further evaluated and repaired as necessary prior to closing by an AC technician.**
- **A service contract to cover minor maintenance and repairs to the AC system.**

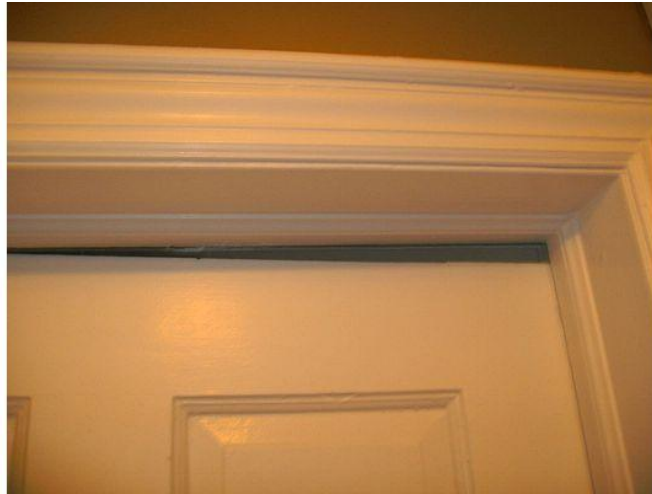
- **Some door frames on the second floor are significantly out of square, indicating structural wall and floor settlement over time.**

- Most doors were in generally functional condition.
- **As described in the Structural Supports section, the master bedroom door frame is out of alignment. The door has been cut to fit, but it has been poorly cut, and there is a significant gap visible at the top of the door frame when the door is closed.**

Gap at top of door

- **Have the master bedroom door modified or replaced to eliminate the gap.**

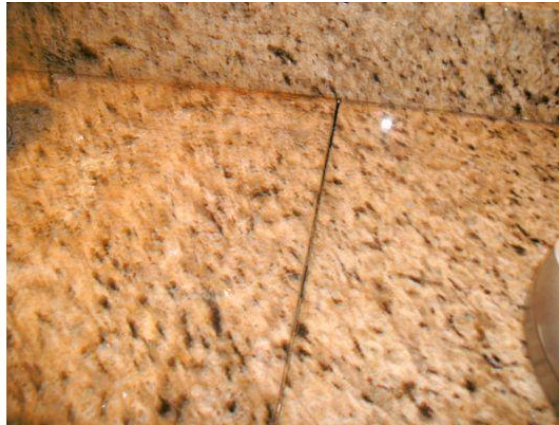
Kitchen cabinets and countertops are in functional condition, **with the exception of a significant gap between two counter top sections. Gaps in counter tops can result in unsanitary conditions.**

Counter top gap
