**HOME INSPECTION REPORT**

**Street Address Removed**

**Montclair, NJ**

The following are the findings of a **Home Inspection** of the subject property done on March 6, 2009. This report is for the use of Client name removed.

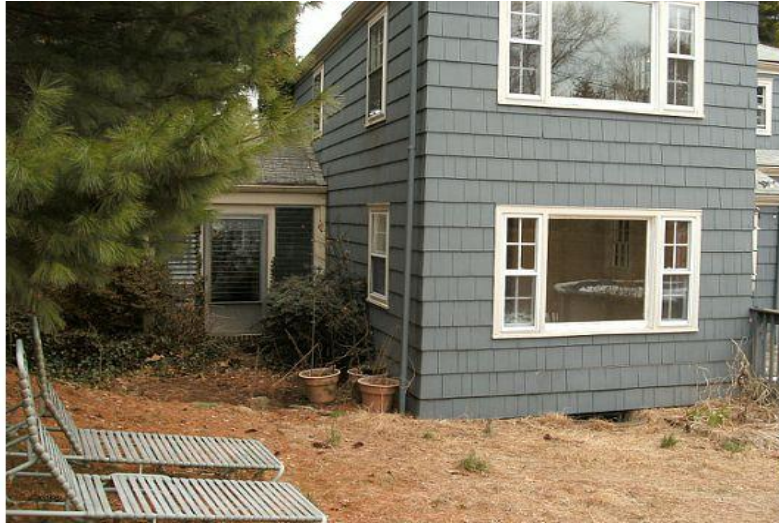
Back, Right: **Inadequate – Soil is in contact with siding and structure in some areas. This is conducive to wood destroying insect entry, which has occurred.**

Soil in contact with siding and structure

- **Modification of grading and possible addition of retaining walls and drainage on the right side and right rear, to keep soil away from structure and divert water away from the house.**

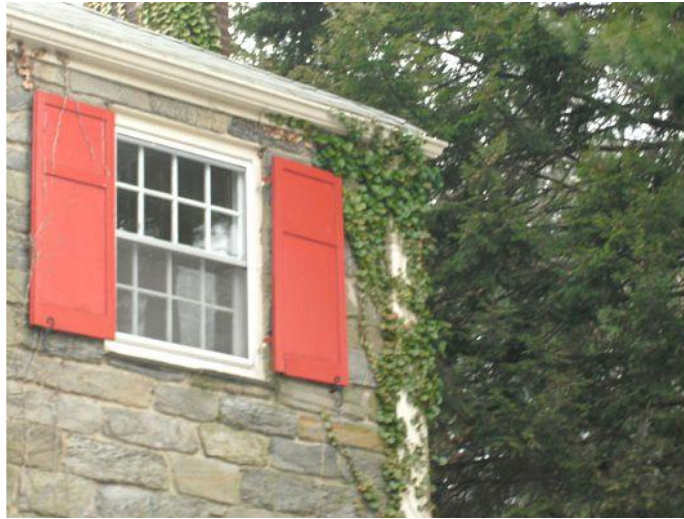
- **Significantly overgrown vine growth and other vegetation are close to or in contact with the sides of the house in many areas.**
- **Trees or tree branches are very close to and/or overhanging the home, particularly at the right front. One of these is a large tree that may be dead.**

Vine growth on the home

**The above conditions are conducive to wood destroying insect entry. Trees overhanging the home could result in damage to the home.**

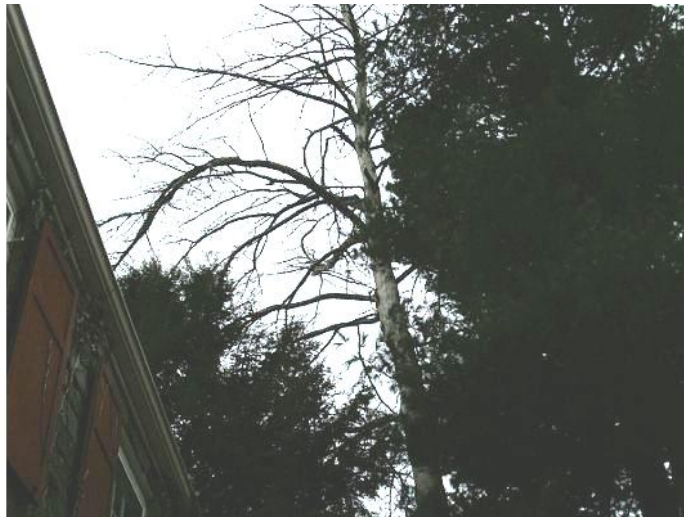
Large trees at the right front

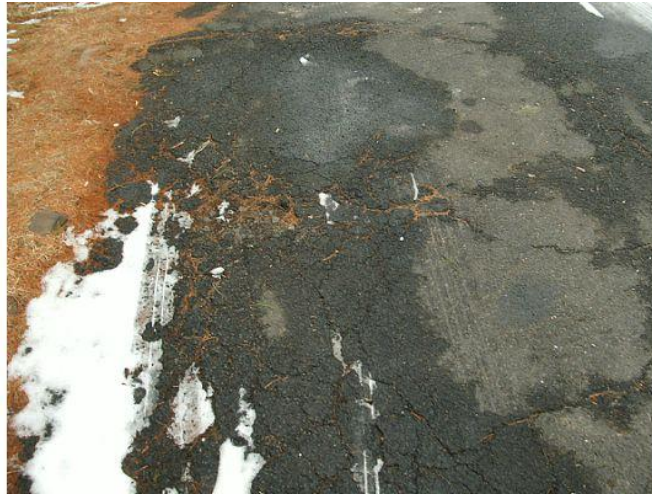
Driveway Condition: **Significant wear, cracking and deteriorated surface.**

Driveway is badly deteriorated

- **Have the driveway re-paved.**
- **Have the paths repaired / replaced as necessary.**
- **Budget for future repair to the sidewalk.**

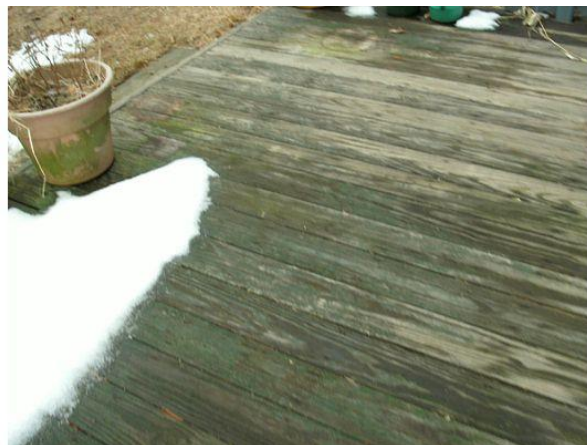
Surface Condition: **Significant wear to most wood on the surface, stairs and railing.**

Deck surfaces are very worn

- **Have a qualified contractor familiar with modern deck construction repair, renovate or replace the deck as necessary.**

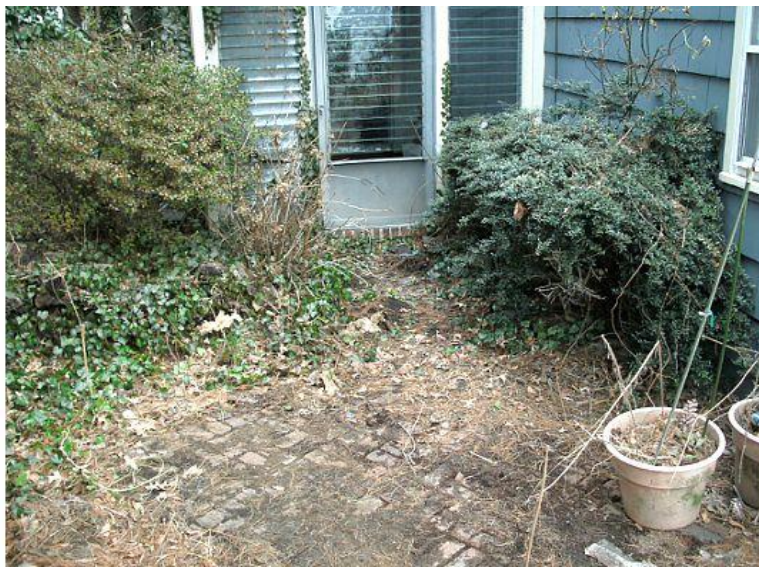
Condition: **Significant wear on many areas of the exterior patios. The covered attached patio has significant vine growth, as well as water and insect damage to wood posts and trim surrounding the patio.**

Worn exterior patio

- **Have exterior patios repaired or replaced as necessary.**
- **Have vine growth removed.**
- **Have water and insect damaged wood replaced by a qualified contractor.**
- **See separate wood destroying insects report from Terminite, Inc.**

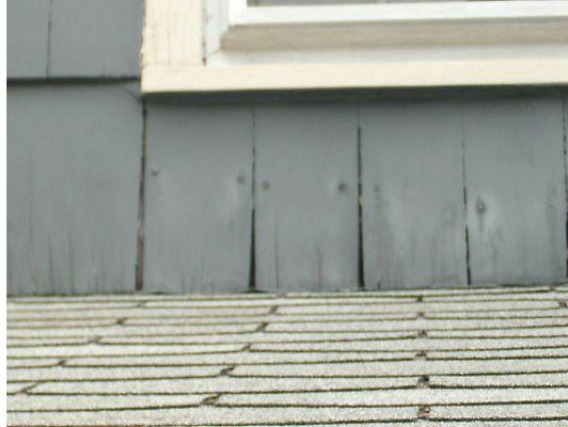
- **Sections of wood shingles at the rear have been replaced, however significant wear is present and nail heads are exposed. This can lead to water entry under wood shingles.**

Worn wood shingles

- Have vine growth removed, and have maintenance and repairs performed to facades as necessary.
- Have water and insect damaged sections of wood trim replaced.
- Have stone trim repaired or replaced as necessary by a qualified mason.

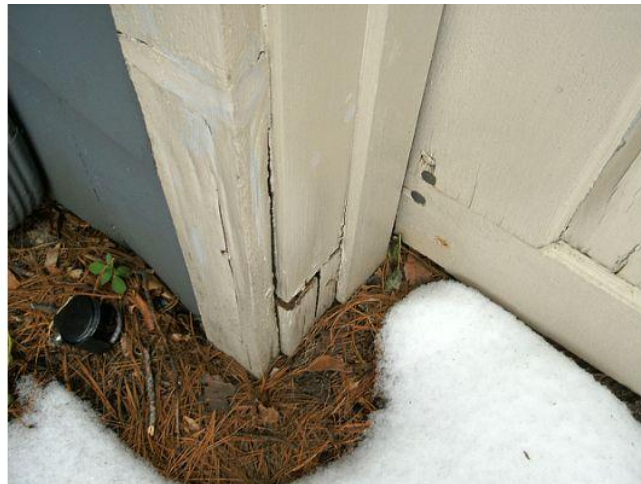
- **Many areas of trim have sustained significant water and insect damage, including the garage door legs and window sills, as well as right side patio trim.**

Damaged trim at garage

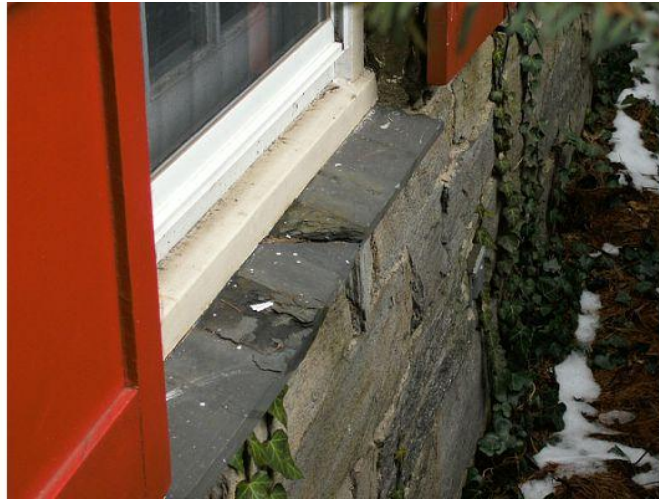
- **Extensive vine growth has likely caused damage and wear to trim.**
- **Some stone trim on front windowsills is worn and damaged.**

Worn stone trim

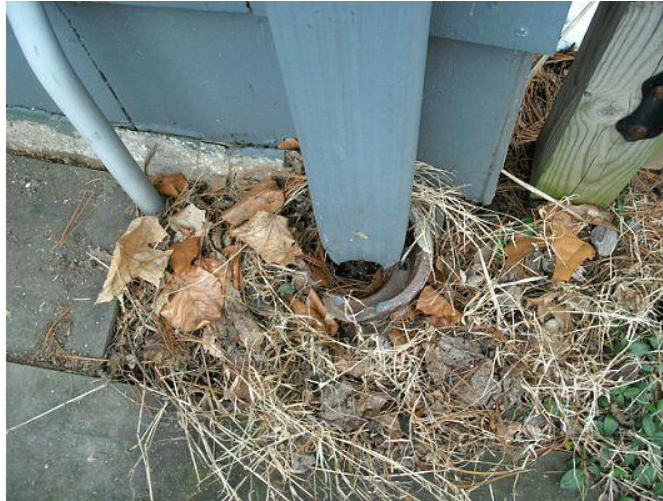
- Gutters appear to be clogged.
- Some downspouts discharge too close to the base of the home.
- Some downspouts discharge into older underground pipe. This older pipe appears to be clogged, and is likely broken and clogged underground.

Older underground drain pipe

- Have all sections of aging underground downspout drain pipe replaced, or abandon the pipe and discharge above ground, and away from the base of the home.
- Direct all above ground downspout discharge points as far away and downhill from the base of the home as is practical.
- Roof drainage on the right side of the house may require more extensive diversion away from the base of the home, due to slope and grading on the right side.
- Have the roof drainage system cleaned and maintained on a regular basis by a qualified gutter maintenance company.

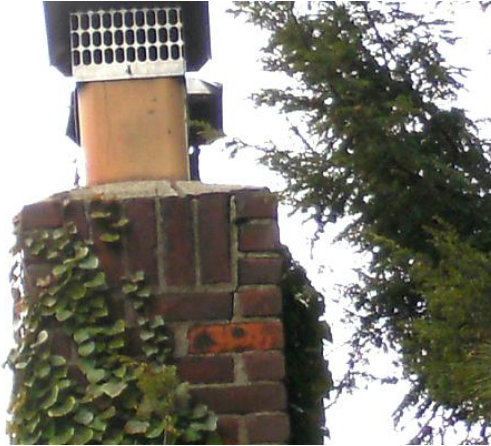
- Some cracks, loose and missing sections of mortar were seen on the upper sections of the chimney. Lack of maintenance to the exterior, and visible exterior damage strongly suggests the presence of interior hidden defects.
- Chimney flashings appear to be older. Leakage is more likely to occur around older chimney flashings.
- Significant vine growth has likely caused damage to brick masonry.

Damage and vine growth on the masonry chimney

- The National Fire Protection Association and the National Chimney Sweep Guild recommend that, due to the advanced age or other conditions, a Level-2 Inspection of the chimney and internal components be done to rule out hidden potential safety defects, and we recommend this as well.
- Have vine growth removed from the chimney.
- Have a qualified chimney contractor service or repair the chimney as required to assure long term function and safety.

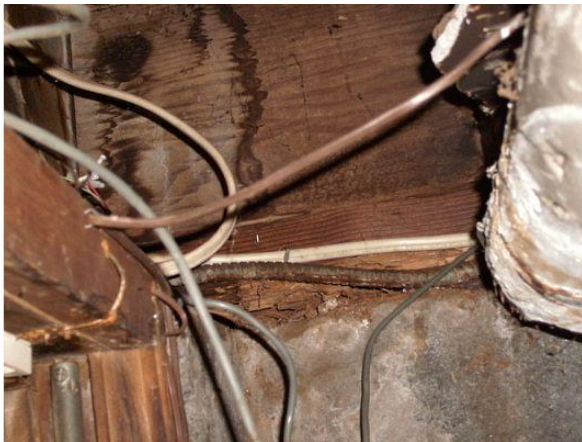
- **Wood sill plates at the right front corner of the home have been damaged by Termite infestation.**

Termite damaged sill plates visible in basement

- **See Roof Drainage section – make sure water around the home is well controlled, with no accumulation near the base of the home. This can help reduce the possibility of foundation settlement in the future.**
- **See the separate wood destroying insect report from Terminite, Inc. for more information relating to the wood framing of this home. Since evidence of wood destroying insect infestation was found, then be aware that further evaluation would be required to assure that additional hidden damage to structural members is not present.**
- **Further evaluation of floor framing for insect and other damage by a qualified contractor familiar with wood destroying insect damage repair. A full evaluation will likely require removal of some ceiling and possibly wall finish materials. Repairs should be made to any damaged areas of structure as necessary.**

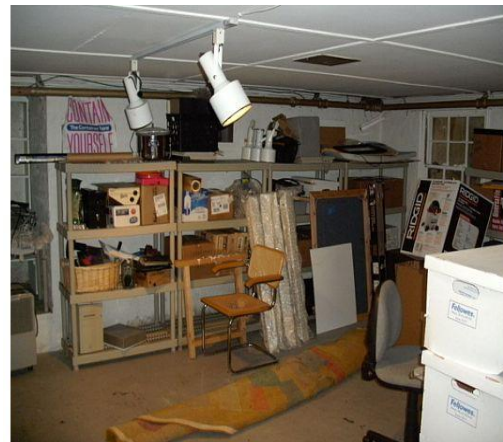
Fixed covering on basement ceiling prevents full evaluation

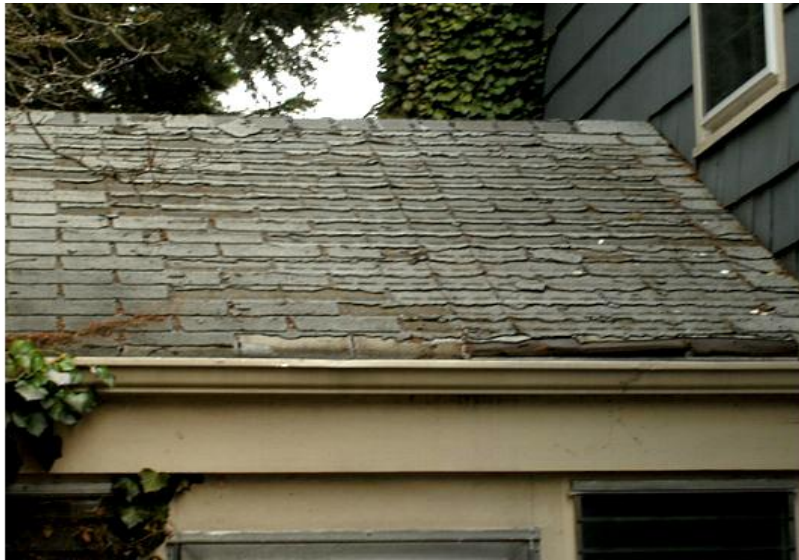
- **Roof shingles are completely worn out in some areas, and have very significant wear in other areas.**

Worn out roof shingles

- **Replacement of this worn out roof at this time, *before* significant leakage occurs.**
- **All existing shingles and flashings should be removed, and new, high quality shingles and flashings should be installed. Any damaged wood should be replaced.**
- **The above work should be done by an experienced roofer.**

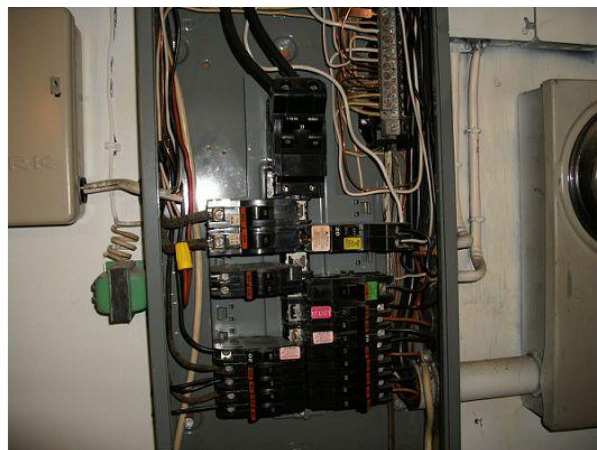
- **This circuit breaker panel is a Federal Pacific brand panel, with StaBlok circuit breakers. These brands of equipment are known to be defective. The circuit breakers may not trip reliably when overloaded. This can result in wiring damage and fires.**

Federal Pacific breaker panel – known to be unsafe

- **Have a licensed electrician replace the Federal Pacific breaker panel and StaBlok breakers with a new, approved breaker panel and new breakers, eliminating the double tapped condition in the process. At the time of replacement, service capacity should be increased to 200 amperes.**
- **Have a licensed electrician install functional GFCI electrical receptacles in all wet areas of the home including kitchens and bathrooms that lack them.**
- **Have a licensed electrician evaluate the home with regard to knob & tube wiring. If found to be present, it is advisable to have such wiring disabled and/or removed, with the affected circuits replaced with approved wiring.**
- **Have a licensed electrician ensure all junction boxes and other electrical connections are appropriately covered or enclosed.**

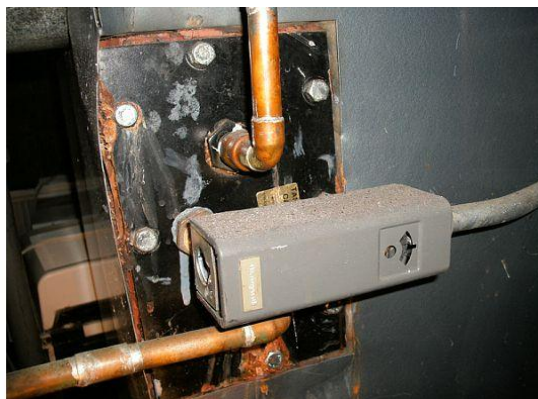
- **Significant corrosion is present at the hot water coil connection plate.**

Corrosion at hot water coil connection

- See Heating System section of this report for additional information..
- Hot water coil maintenance could be required, however maintenance or replacement should be done in conjunction with heating system repairs, maintenance or replacement.
- If the heating system is replaced, installation of a separate gas fired hot water heater may be required or may be advisable.

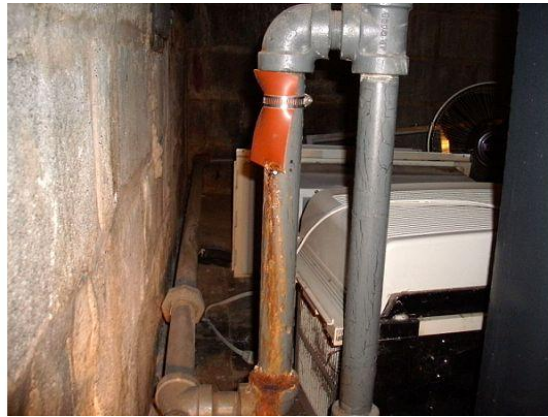
- **The heating components are more than 50% through designed service life, the possibility of hidden internal defects that can affect function and safety is increased.**
- **Significant visible corrosion present, which suggests hidden defects.**
- **Active leakage occurring from steam return pipes near the heating system.**
- **Significant corrosion on many sections of steam pipes / steam return lines.**
- **Radiators and steam or circulated water pipes are older, and the need for increased maintenance and repair to these older components should be anticipated.**

Amateur patch on steam return pipe

- **Further evaluation of the heating system by a qualified specialist to assure that hidden defects or safety related issues are not present. Because of significant corrosion, replacement may be required, regardless of whether the system has reached its designed service life.**
- **Evaluation and repair of all leaking and corroded sections of steam pipes.**
- **Monitor radiators and radiator connections for leakage, and have any leaks repaired promptly.**
- **Oil heating equipment requires annual service. Have the oil heating equipment serviced annually by a qualified oil heating technician.**
- **See Fuel Oil Storage section – because of problems with the oil storage tank, you may wish to replace this aging heating system and convert to natural gas heat at this time.**

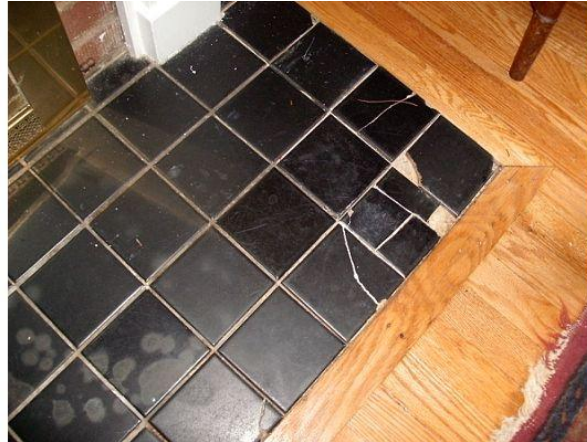
Hearth area Condition: **Loose and broken tile.**

Loose, broken hearth tile

- **See Chimney section.**
- **Have a qualified chimney / fireplace contractor clean the fireplace and chimney flue(s).**
- **Have loose hearth tile repaired or replaced.**
- **Have loose doors repaired / replaced.**

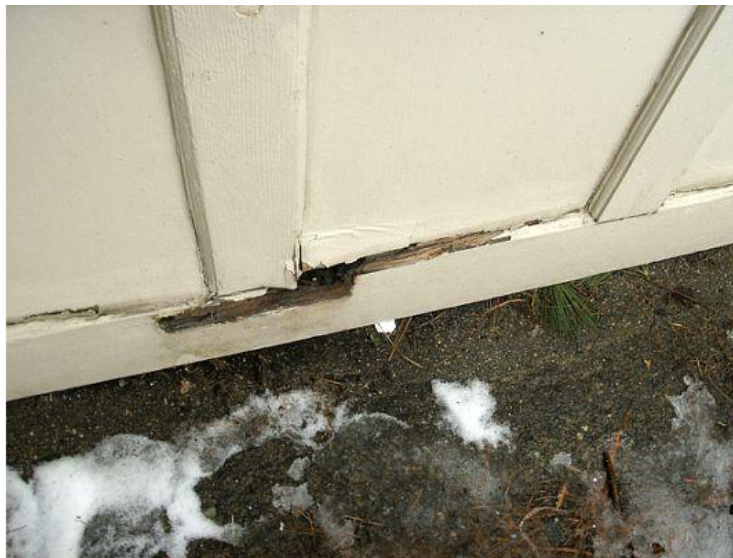
**The door has significant wear and water damage.**

Damaged garage door

- **Have the garage door replaced by a qualified garage door contractor.**
- **Removal of stored items and re-inspection of the garage.**

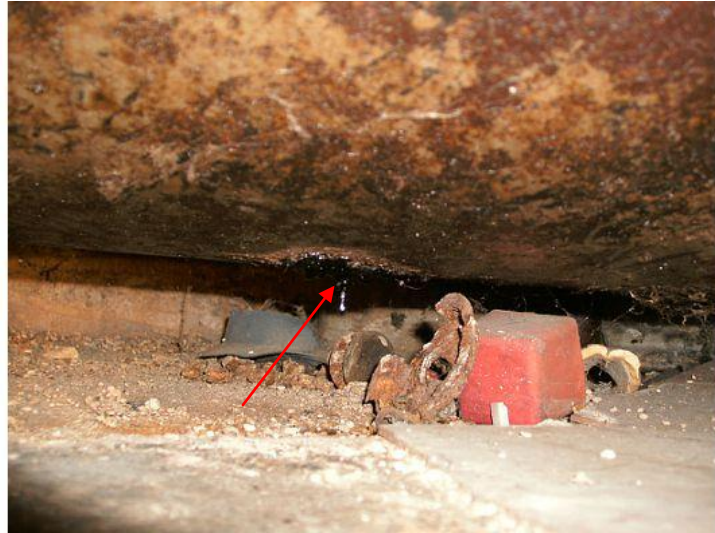
**The tank appeared to be in older condition, is corroded, and may be leaking.  
Congealed, dripped oil is present at the bottom of the tank.**

Hardened oil drip at the bottom of the oil tank

**Please note that steel tanks corrode from the inside out, and eventually fail and leak. Only an inspection using specialized equipment can determine the remaining life of the tank.**

- **Further evaluation of the oil storage tank by an oil tank specialist, with replacement if the tank is found to be leaking or found to be aged to a point where leakage is likely.**
- **Specialist search for abandoned buried tanks and specialist evaluation of buried and/or above ground oil storage tanks, either in use or abandoned. As leaking oil tanks can result in significant expenses, we advise careful review with legal counsel of any documents or statements relating to oil tank(s).**
