May 17, 2008

**HOME INSPECTION REPORT**  
**Street Address Removed**  
**Morristown, NJ**

The following are the findings of a **Home Inspection** of the subject property done on May 14, 2008. This report is for the use of Client name removed.

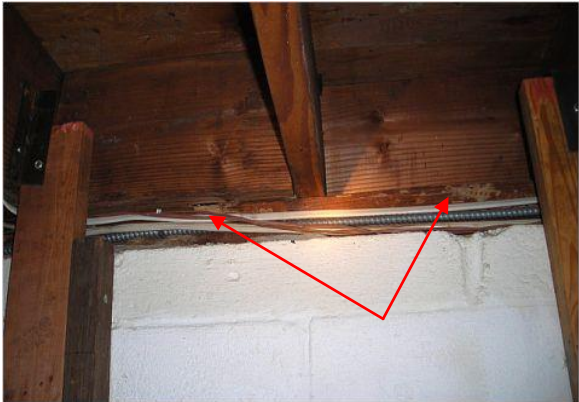
- **The front sill plate and floor joists have been damaged by a wood destroying insect infestation.**
- **There is evidence of a termite infestation as indicated by mud shelter tubes coming through the fixed wall covering in the garage, and this suggests that hidden damage may be present to the framing behind the wall.**
- **A section of the main beam has been replaced, most likely as a result of prior wood destroying insect damage to the original beam. This new beam appeared to be in satisfactory condition.**

Termite damaged sill plate, left front

- **Have a qualified contractor familiar with wood destroying insect damage repair further evaluate termite damaged sections of floor framing, and make repairs as necessary to assure structural adequacy.**

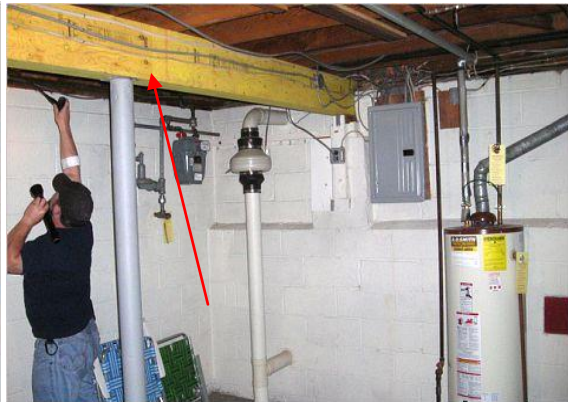
New beam installed, near left front

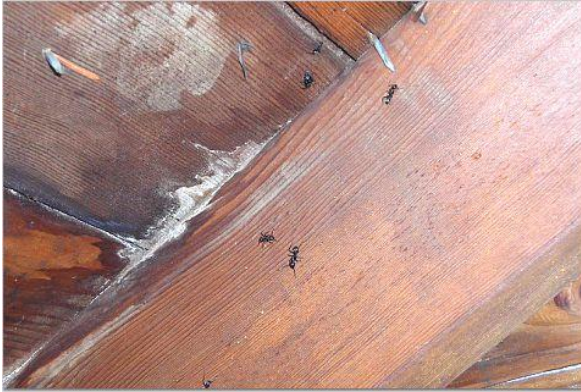
Live ant activity in stained area under roof

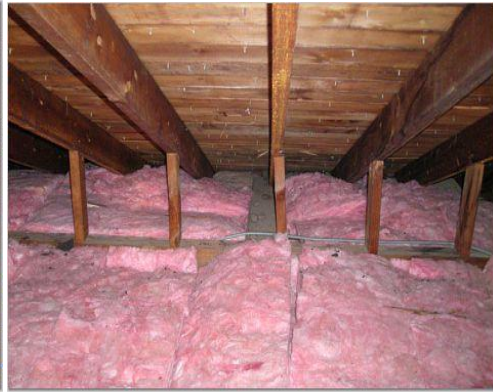
Insulation may be blocking soffit vents

**Roof ventilation may not be adequate due to blocked or inadequate soffit vents.**

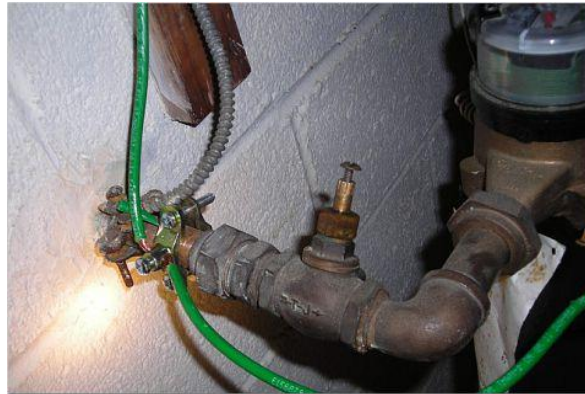
Main Shutoff Valve Condition: **The main water shutoff valve knob is missing.**

Missing main shutoff valve knob

- **Have a plumber evaluate the main water shutoff valve and repair or replace it as necessary to assure reliable function.**
- **Have a plumber replace any older water supply shutoff valves with corrosion or leakage, and repair any corroded or poorly done water pipe connections.**
- **To determine the true condition of the waste and drain pipes we recommend that a plumber inspect them internally using a specialized video camera.**

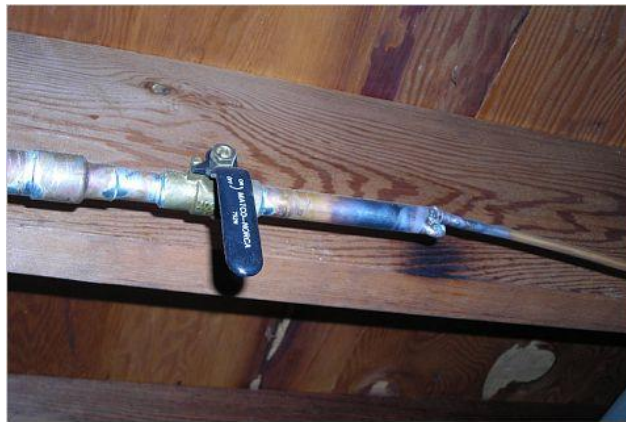
- **Some older and corroded water supply shutoff valves and connections are present.**
- **A poorly crimped and brazed connection from a larger water pipe to a smaller pipe is present.**

Poorly done connection

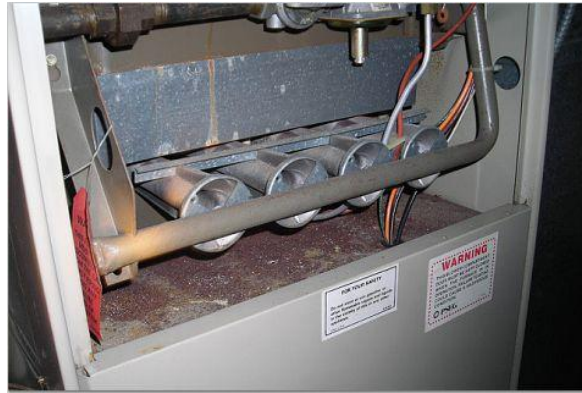
- **The heating components are past the end of its designed service life, and remaining service life is undeterminable by us. In addition, for old equipment, the possibility of hidden internal functional and safety related defects is significantly increased.**
- **Significant visible corrosion present, which suggests hidden defects.**

Furnace is aging and has corrosion

- **Replacement of this old heating system.**
- **Be sure that the unsafe thermally activated flue damper is removed.**
- **A service contract to cover future maintenance and repairs to the heating system.**

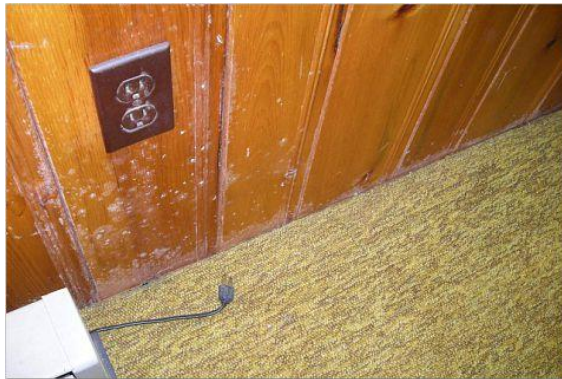
- **Most areas of paint or finish surface are worn.**
- **Wood paneling at the right rear has spotted areas near the floor, suggesting the possibility of moisture entry and possible mold growth behind paneling (see Basement and Mold sections).**
- **Walls in the garage show evidence of termite activity.**

Spotting from mold growth on wood panels
