April 28, 2008

HOME INSPECTION REPORT

XXXX Street

Nutley, NJ

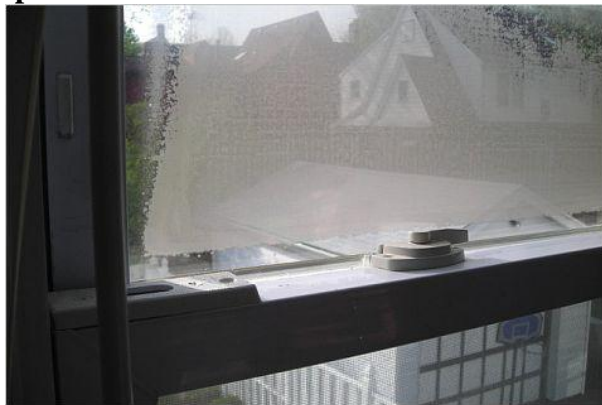
- Most windows were found to be in functional condition.
- **Windows in the right rear bedroom have condensation staining between the double glazing, which is usually a result of defective thermopane seal. This is generally not possible to clean.**

Condensation stained window

- **Have stained window glazing in the right rear bedroom replaced.**

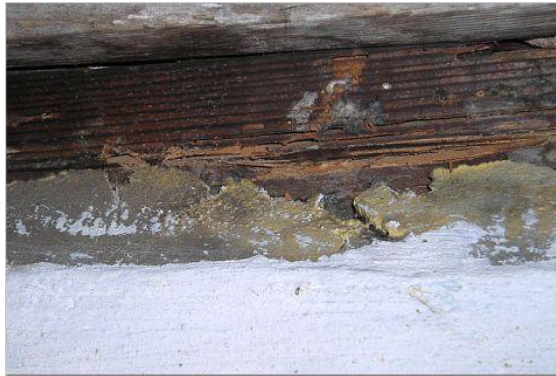
- **Some sections of the flooring are not level, particularly in the kitchen.**
- **Termite damage is present at the rear wood sill plate, between the basement and rear crawlspace.**

Termite damaged sill plate

- **Have a qualified contractor familiar with wood destroying insect damage repair further evaluate and repair termite damaged sections of structural framing.**
- **See the separate wood destroying insect report from Terminite, Inc. for more information relating to the wood framing of this home. If evidence of wood destroying insect infestation is found, then be aware that further evaluation would be required to assure that hidden damage to structural members is not present.**
- **Have a qualified contractor repair or adequately reinforce the cracked and notched rafters in the attic.**
- **See Roof Drainage section – make sure water around the home is well controlled, with no accumulation near the base of the home. This can help reduce the possibility of foundation settlement in the future.**

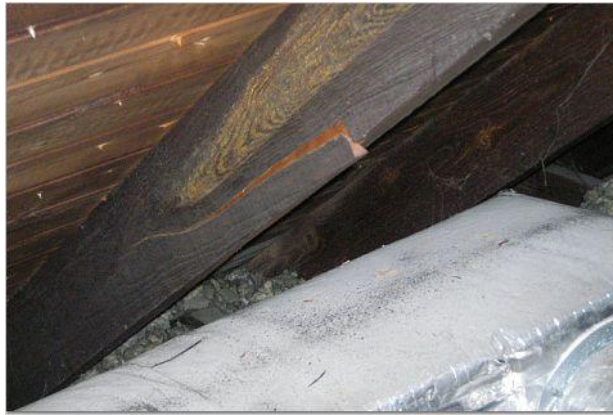
- **One roof rafter is cracked.**

Cracked roof rafter

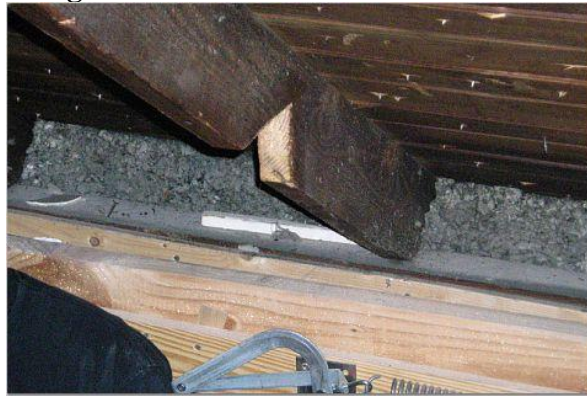
- **One roof rafter near the attic entry has been notched to allow the attic hatch to close, weakening the rafter.**

Notched rafter is weakened

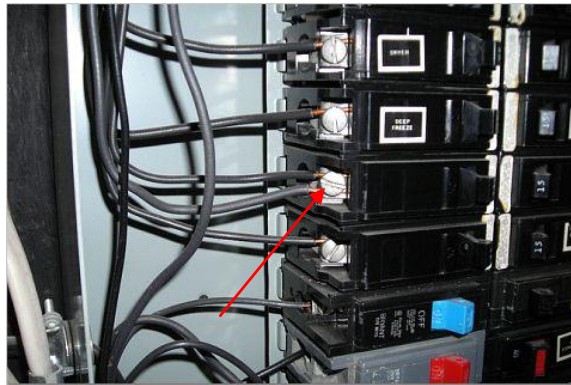
- **Two double tapped circuit breakers (more than one wire connected to a circuit breaker) are present in the panel. This is incorrect wiring technique.**

Double tapped breaker

- **Have a licensed electrician eliminate the double tapped condition in the circuit breaker panel and evaluate the components within the panel for hidden damage from water entry and repair as may be needed.**
- **We recommend an upgrade in electrical service capacity to 200 amperes.**
- **Have a licensed electrician install functional GFCI electrical receptacles in all wet areas of the home including kitchens and bathrooms that lack them.**
- **Have a licensed electrician evaluate the home with regard to knob & tube wiring. If found to be present, it is advisable to have such wiring disabled and/or removed, with the affected circuits replaced with approved wiring.**
- **Have a licensed electrician cover any open junction boxes or exposed electrical connections.**

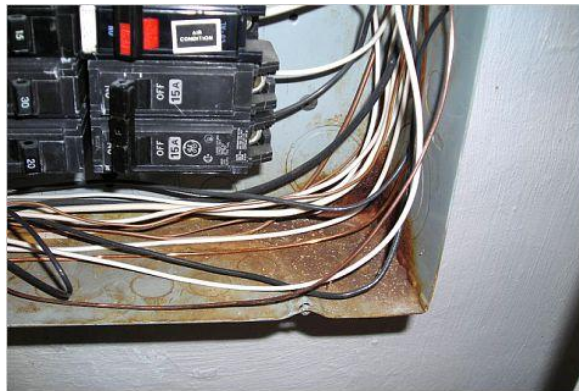
- **The panel is small and is full.**
- **Some corrosion is present in the circuit breaker panel, which suggests prior water entry.**

Panel corrosion

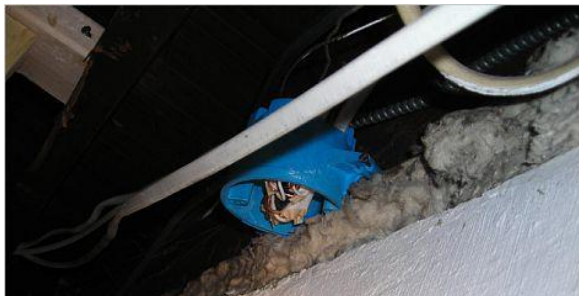
- **Some uncovered electrical junction boxes were found behind finish walls in the basement.**

Uncovered electrical junction box

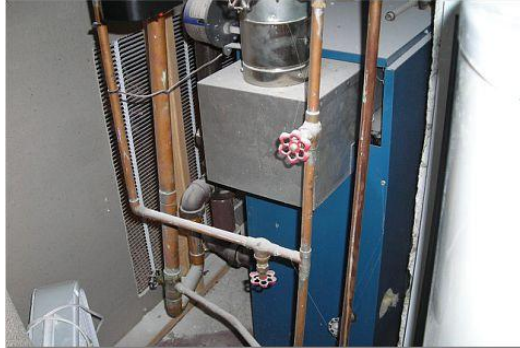
- *Space in the heating utility closet is very restricted. Although the heating system is newer and appeared to function normally, we could not fully evaluate the heating system due to this restricted access.*

The back of the heating system – Front was not accessible or visible

- **See Basement section – finish materials must be modified to allow better access to the heating system components. The front of the boiler must be accessible for routine service.**
- **Further evaluation by a qualified specialist evaluation to assure that hidden defects or safety related issues are not present.**
- **Monitor radiators and radiator connections for leakage, and have any leaks repaired promptly.**
- **A service contract to cover future maintenance and repairs to the heating system.**

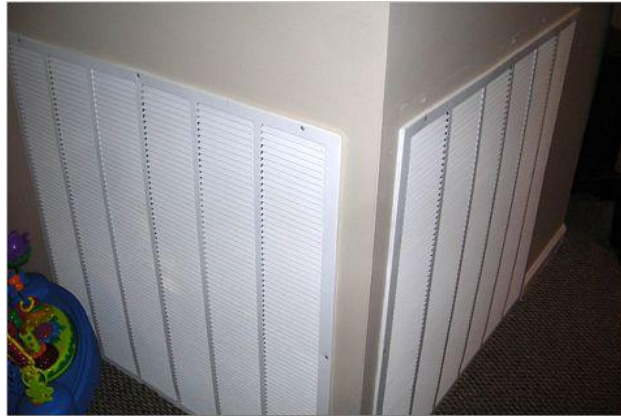
- **Finish materials in the basement are incorrectly installed, partly or fully obstructing access to virtually all sections of structure as well as the heating system and utilities. The circuit breaker panel, water main, gas meter and main and heating system would all require removal of finish materials for service or replacement, which is not an acceptable condition.**

Heating system is behind fixed grills – even with grills removed, system could not be adequately serviced

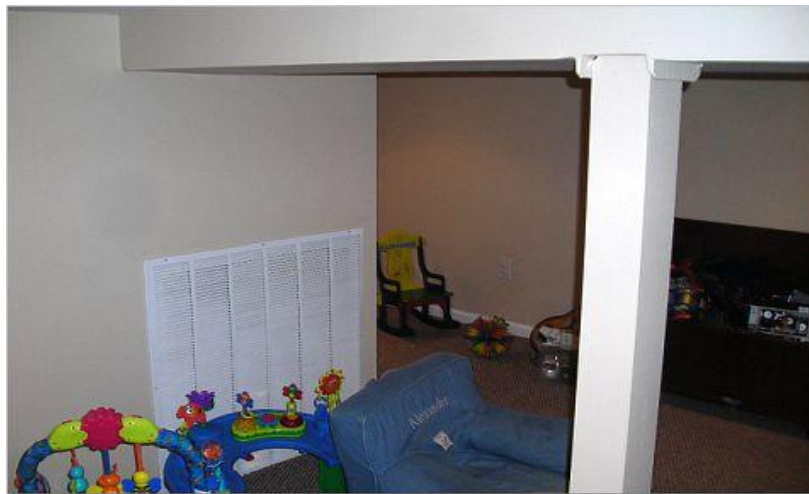
- **Basement finish walls are recently built with wood studs. The studs used for the sill plate (bottom plate, in contact with basement floor) are not pressure treated, and are hence more vulnerable to decay and wood destroying insect damage.**
- **The basement ceiling height is very low. Recessed lighting in the ceiling contacts the heads of many normal height adults. Minimum acceptable clearance for finished living space appears to be inadequate.**
- **The front and rear crawlspaces are totally enclosed, with no access either from the interior or exterior. This could create conditions conducive to mold growth, and obstructs access to some piping. These spaces could not be inspected.**

Basement is newly finished with fixed walls everywhere, and no access to utilities'

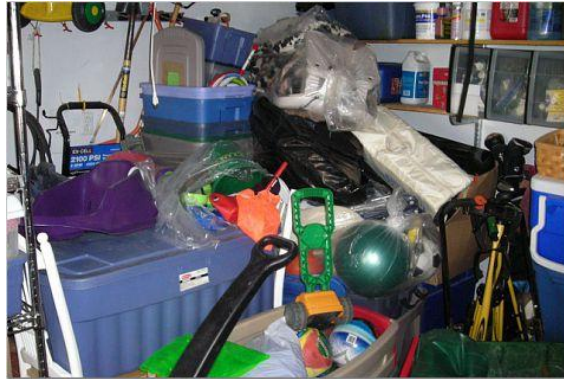
- **Termite damage is present along part of the garage sill plate.**
- **Nearly all the garage walls are covered with finish materials on the interior, so it is not possible to determine the extent of termite damage. In addition, the**

garage was overcrowded with stored items, limiting our inspection.

Garage is totally finished and crowded with stored items

- See the separate wood destroying insects report from Terminite, Inc.
- Further evaluation and repair of the garage structure by a qualified contractor familiar with wood destroying insect damage repair. This will likely require removal of finish materials in the garage.
- To the extent possible, lower soil levels around the garage.
