April 30, 2008

**HOME INSPECTION REPORT**

**## XXXXX Lane**

**Piscataway, NJ**

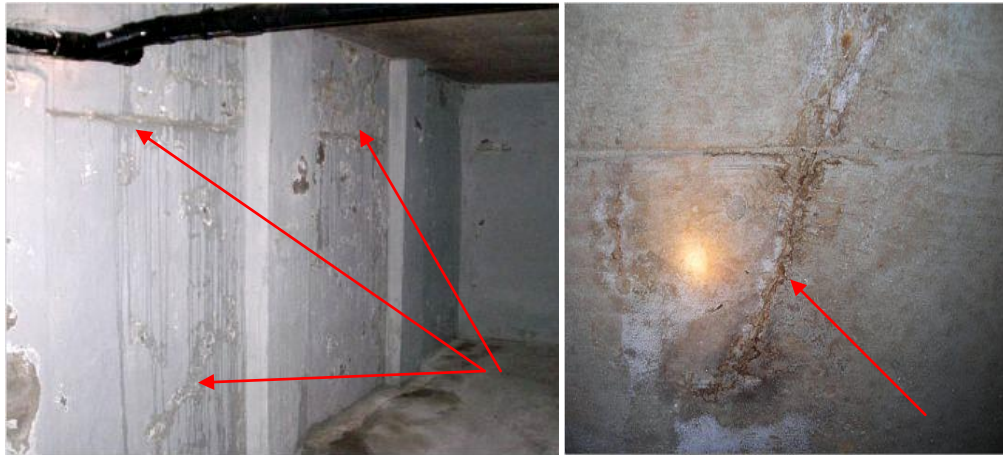
- Foundation walls in the main part of the basement are functional where visible.
- **Water penetration into the foundation and the area under the front entry landing is taking place and is a condition that can eventually cause structural damage to the masonry foundation. Much of the water penetration appears to be a result of leakage through the concrete masonry front entry landing, which is exposed to the weather. Water entry through masonry entry landings above interior basement areas is difficult to eliminate, and is a common problem for this type of construction. Leaks through the concrete landing area are a result of cracks in the concrete, and small gaps and cracks at joints where the landing slab meets the perimeter walls.**

Water Entry & Damage to the Masonry Foundation at Front and also Crack and Water Entry thru Ceiling

- **Further evaluation of the front entry landing slab to determine what measures are needed to effectively seal this area to prevent water penetration.**
- **See Roof Drainage section and Soil Grading & Drainage section – make sure water around the home is well controlled, with no accumulation near the base of the home. This can help reduce the possibility of foundation settlement in the future.**
- **See the separate wood destroying insect report from Terminite, Inc. for more information relating to the wood framing of this home. If evidence of wood destroying insect infestation is found, then be aware that further evaluation would be required to assure that hidden damage to structural members is not present.**

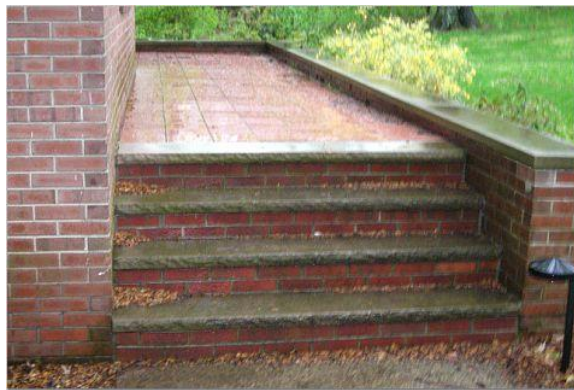
- The lot is sloped from the front to the rear. Water entry is more likely at the front of the home, and water entry appears to be occurring in front of the front entry area, into the basement area below the front entry. This is due in part to water draining off the front entry, and not being diverted away from the base of the home in the front.

Front entry area is sloped to drain water to front, where it accumulates  
The area beneath this entry is a full height crawlspace

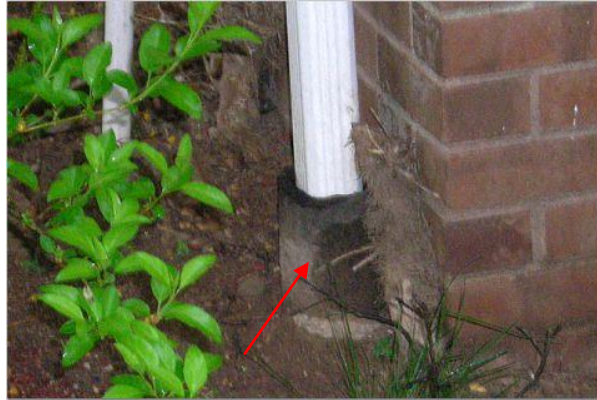
- **Most underground drain pipe is older tarpaper pipe, which can crush or clog underground. Several of these underground pipes appeared to be clogged with leaves and debris.**

Older tarpaper underground pipe

- **Observe all underground pipe connections during heavy rains to determine whether they are clogged or free flowing.**
- **If possible, have any clogged pipe cleared, however this type of pipe tends to clog and crush underground, and has a limited lifetime. Pipe replacement or diversion of water above ground may be necessary.**
- **Direct all above ground downspout discharge points as far away and downhill from the base of the home as is practical.**

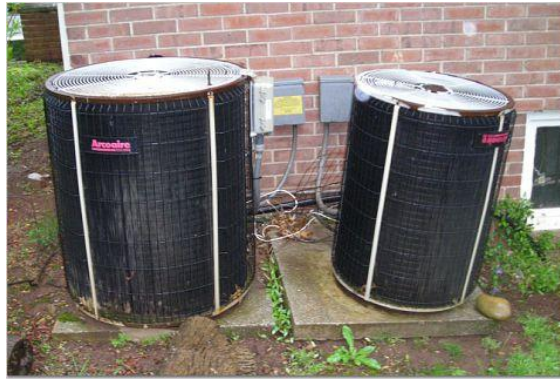
- **The AC compressor/condensing units appear to be past the end of their designed service life. Continued reliable operation cannot be assured.**
- **One of the AC compressor/condensing units is out of level.**

Older central AC compressor/condensing units have limited if any remaining life

- **Have the AC systems tested when weather is warm enough (consistently above 65F), repaired or replaced as necessary, and serviced annually by an AC technician.**
- **Have the out of level AC compressor leveled.**
- **Budget for replacement of the AC compressor/condensing units in the near future.**
- **A service contract to cover future maintenance and repairs to the AC systems.**

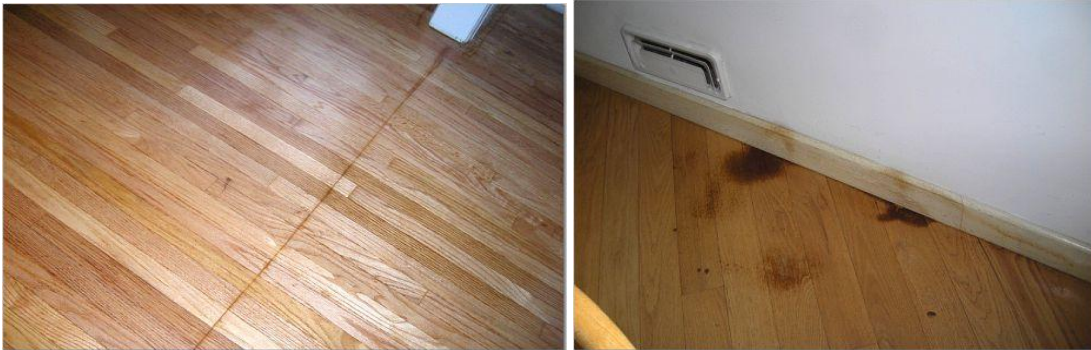
- **Some areas of finish floor are worn.**
- **Wood flooring in the living room and dining room has score marks from a knife, possibly from ripping up old carpeting. Although refinished at some point, these score marks remain clearly visible.**

Defects in Finish Wood Flooring

- Refinishing of scored and stained wood floors
- Replacement of any worn flooring as desired.

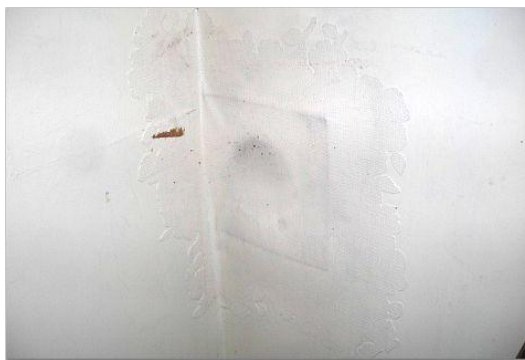
**The dryer vent opening has been covered over with fabric and tape and painted.**

Closed over dryer vent outlet

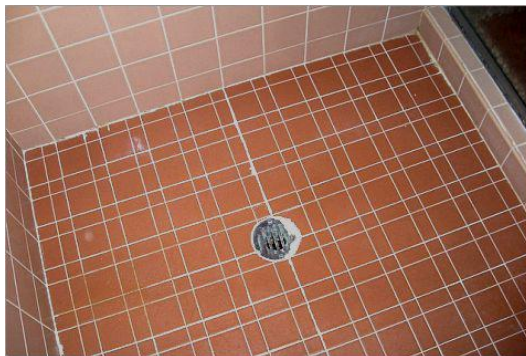
- **All bathroom fixtures, faucets, plumbing and surfaces are older. Leakage, breakage, and the need for repairs should be anticipated.**
- **The stall shower in the left side bathroom over the den has cracked tile, and appears never to have been replaced. Leakage can occur through worn tile shower floors such as this, and leakage from this shower may have caused ceiling staining and damage in the den below.**

This older tile floor is likely leaking

- **Have the tile shower floor in the left side bathroom replaced by a qualified tile contractor and plumber.**
- **Have the loose toilet repaired.**
- **Have a solid surface fiberglass tile base installed in place of the concrete shower floor in the basement bathroom.**
- **See Electrical section.**
- **Budget for renovations and repairs to the bathrooms in the near future.**

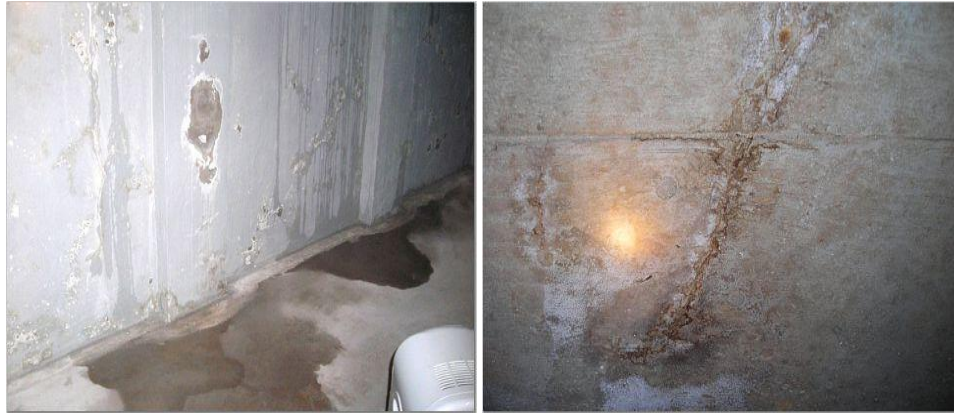
- **Signs of prior water entry were found to be present along some unfinished foundation walls in the basement.**
- **Water entry was occurring through the front wall and the ceiling below the**

**front entry landing.**

Signs of leakage through foundation wall and ceiling – front entry area is above

- **See Roof Drainage section – proper maintenance of gutters and downspouts can reduce the possibility of water entry into the basement.**
- **Installation of additional waterproofing measures, including a sump pump and perimeter drain system if not already present.**
- **Further evaluation of the front entry landing to determine what measures should be taken to eliminate water penetration.**
- **See Soil Grading & Drainage section and Description and Condition of Entrances section. Water around the front entry area must be controlled.**
