April 30, 2008

HOME INSPECTION REPORT

XXXXX Lane

Piscataway, NJ

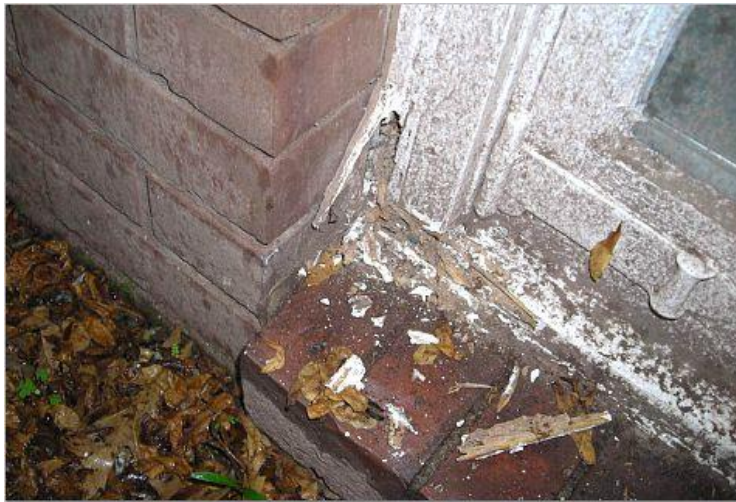
- **Termite damage is present to lower sections of wood window frames on the left side.**

Termite damaged trim

- **See Description and Condition of Entrances section.**
- **See separate wood destroying insects report from Terminite, Inc.**
- **Have damaged sections of wood trim replaced.**

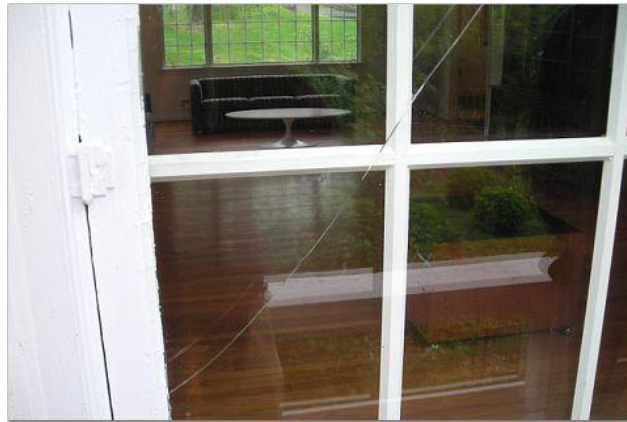
- **Most windows have significant wear.**
- **Many windows appear to have been painted shut. Paint on the exterior is clogged and dried between windows and window frames.**
- **Windows that are not painted shut are stiff and/or difficult to operate.**
- **A number of window panes are cracked, particularly at the back of the home.**

Window with cracked glass, also painted shut

- **Have all cracked windows replaced.**
- **Have paint carefully removed from between windows and window frames to free them.**
- **To the extent possible, have windows repaired, maintained and/or cleaned for better condition and operation.**
- **As an alternative, consider having windows replaced with new, double glazed units.**

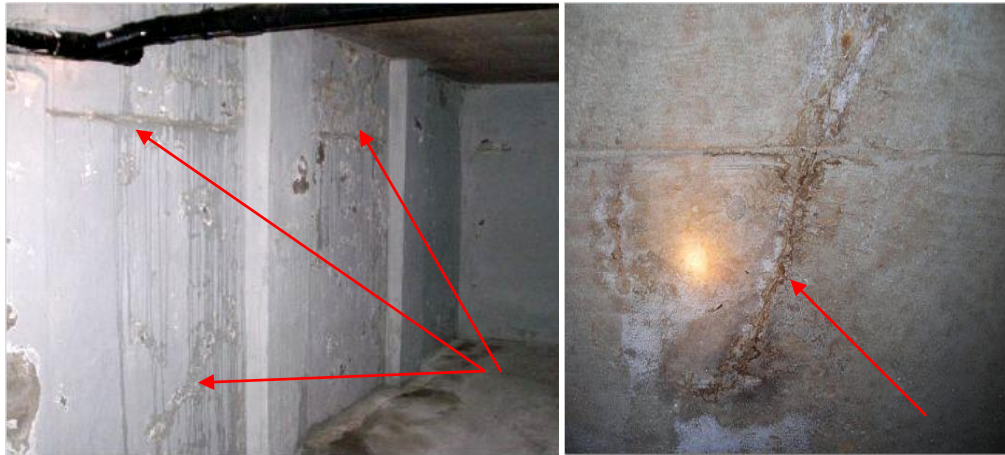
- Foundation walls in the main part of the basement are functional where visible.
- **Water penetration into the foundation and the area under the front entry landing is taking place and is a condition that can eventually cause structural damage to the masonry foundation. Much of the water penetration appears to be a result of leakage through the concrete masonry front entry landing, which is exposed to the weather. Water entry through masonry entry landings above interior basement areas is difficult to eliminate, and is a common problem for this type of construction. Leaks through the concrete landing area are a result of cracks in the concrete, and small gaps and cracks at joints where the landing slab meets the perimeter walls.**

Water Entry & Damage to the Masonry Foundation at Front and also Crack and Water Entry thru Ceiling

- **Further evaluation of the front entry landing slab to determine what measures are needed to effectively seal this area to prevent water penetration.**
- **See Roof Drainage section and Soil Grading & Drainage section – make sure water around the home is well controlled, with no accumulation near the base of the home. This can help reduce the possibility of foundation settlement in the future.**
- **See the separate wood destroying insect report from Terminite, Inc. for more information relating to the wood framing of this home. If evidence of wood destroying insect infestation is found, then be aware that further evaluation would be required to assure that hidden damage to structural members is not present.**

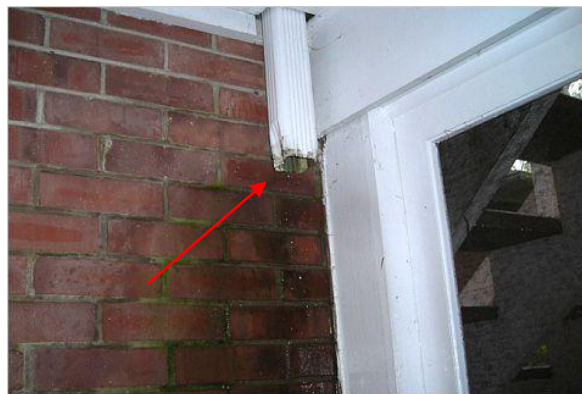
- **A section of downspout running through the enclosed patio has come off, and water is discharging inside the patio area.**

Disconnected downspout discharging into patio area

- **Have missing downspout section(s) replaced.**
- **Have the roof drainage system cleaned and maintained on a regular basis by a qualified gutter maintenance company.**

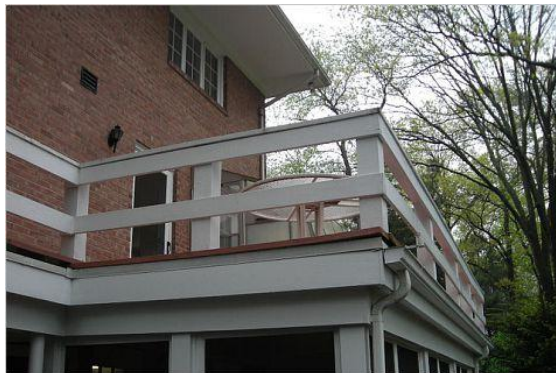
Railing Condition: **The railing is very worn, and has horizontal rails and wide spaces, making it a falling hazard.**

This style railing is no longer considered to be acceptable

- **Have a qualified contractor familiar with modern deck construction evaluate this deck, and make repairs and reinforcements to structure as necessary to ensure long term structural stability.**
- **Have a qualified contractor familiar with modern deck construction replace the railing with a modern type deck railing, with no horizontal elements and narrow baluster spacing.**
- **Have a qualified contractor familiar with modern deck construction repair or replace deck boards where excessively worn.**

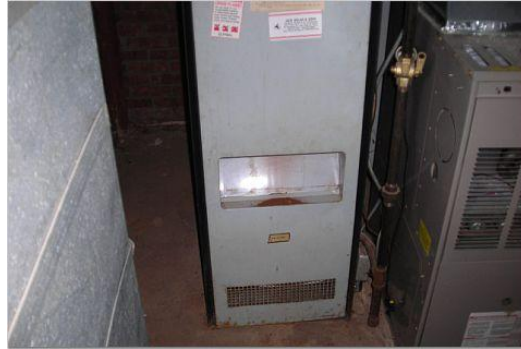
- **The heating system serving the basement space is well past the end of its designed service life, and remaining service life is undeterminable by us. In addition, for old equipment the possibility of hidden internal functional and safety related defects is significantly increased. Significant visible corrosion present on the basement heating system, which also suggests internal defects.**

Very old heating system – note corrosion at front

- **Replacement of the heating system serving the basement with a new unit.**
- **Further evaluation of the heating systems serving the first and second floor by a qualified specialist to assure that hidden defects or safety related issues are not present.**
- **Repair of humidifier(s) as necessary.**
- **A service contract to cover future maintenance and repairs to the heating systems.**

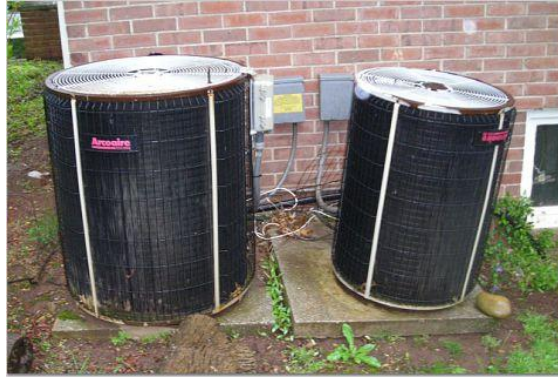
- **The AC compressor/condensing units appear to be past the end of their designed service life. Continued reliable operation cannot be assured.**
- **One of the AC compressor/condensing units is out of level.**

Older central AC compressor/condensing units have limited if any remaining life

- **Have the AC systems tested when weather is warm enough (consistently above 65F), repaired or replaced as necessary, and serviced annually by an AC technician.**
- **Have the out of level AC compressor leveled.**
- **Budget for replacement of the AC compressor/condensing units in the near future.**
- **A service contract to cover future maintenance and repairs to the AC systems.**

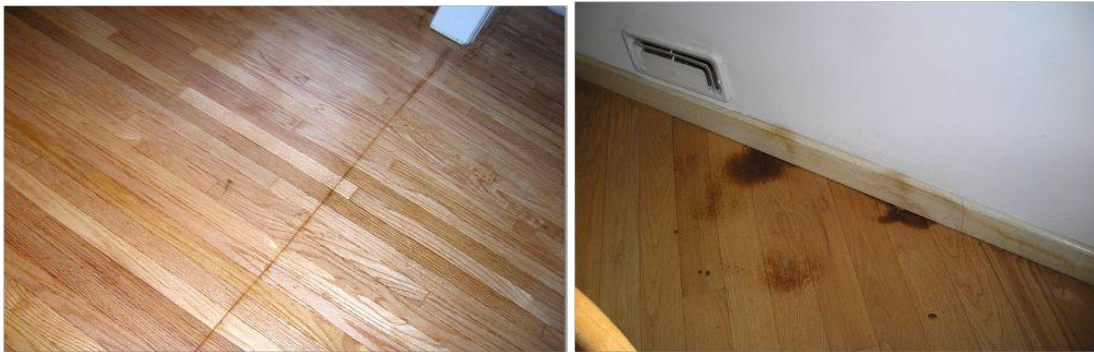
- **Some areas of finish floor are worn.**
- **Wood flooring in the living room and dining room has score marks from a knife, possibly from ripping up old carpeting. Although refinished at some point, these score marks remain clearly visible.**

Defects in Finish Wood Flooring

- Refinishing of scored and stained wood floors
- Replacement of any worn flooring as desired.

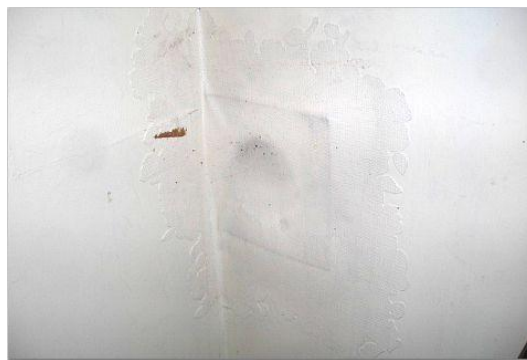
The dryer vent opening has been covered over with fabric and tape and painted.

Closed over dryer vent outlet

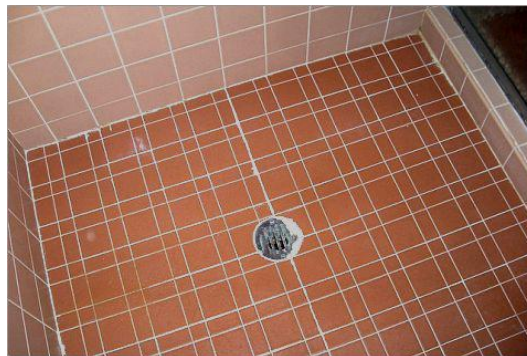
- **All bathroom fixtures, faucets, plumbing and surfaces are older. Leakage, breakage, and the need for repairs should be anticipated.**
- **The stall shower in the left side bathroom over the den has cracked tile, and appears never to have been replaced. Leakage can occur through worn tile shower floors such as this, and leakage from this shower may have caused ceiling staining and damage in the den below.**

This older tile floor is likely leaking

- **Have the tile shower floor in the left side bathroom replaced by a qualified tile contractor and plumber.**
- **Have the loose toilet repaired.**
- **Have a solid surface fiberglass tile base installed in place of the concrete shower floor in the basement bathroom.**
- **See Electrical section.**
- **Budget for renovations and repairs to the bathrooms in the near future.**
