MEYERS HOME INSPECTION SERVICES

July 24, 2007

HOME INSPECTION REPORT 100 Executive Avenue Alps, NJ

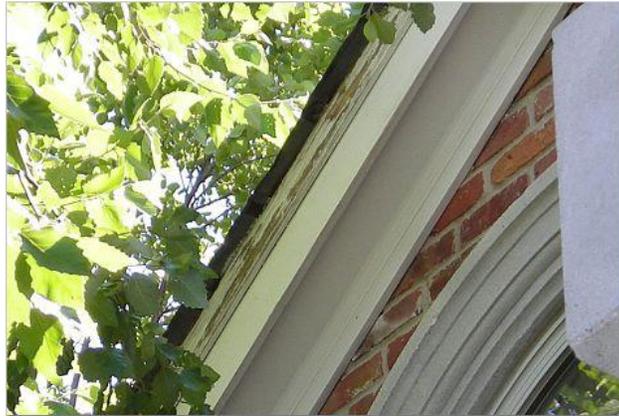
- **Some wood roof edge trim to the left of the front entrance requires re-painting.**

Worn roof edge trim paint

- **Have the roof edge wood trim that has worn and peeling paint prepared, primed and repainted by a qualified painting contractor.**
- **Further evaluation of the EIFS material at the exterior is needed to confirm that it is in satisfactory condition.**

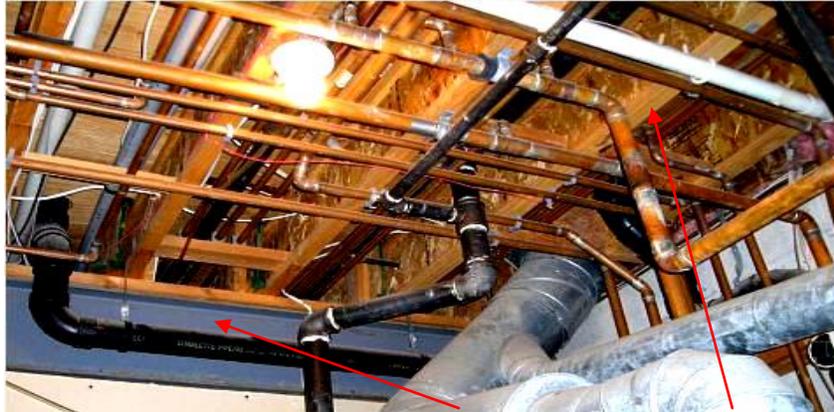
Condition: Flooring throughout the home is adequately level and stiff. Inspection of the visible accessible steel and wood structural framing did not show evidence of significant structural defects.

View of Floor Support Framing, showing Steel Beam & Engineered Truss Joists

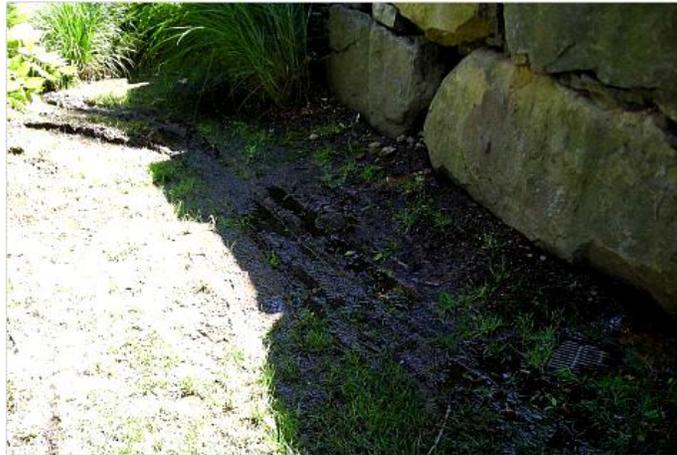
Water accumulation is present at the base of the rear retaining wall on the left side. It is possible that drainage grates and/or the buried drainage system in this area are clogged.

Wet and muddy area at the base of the back retaining wall

- **Have a landscaper or other qualified contractor evaluate the drainage at the base of the rear retaining wall, and clear drains or otherwise repair or modify to provide adequate drainage.**

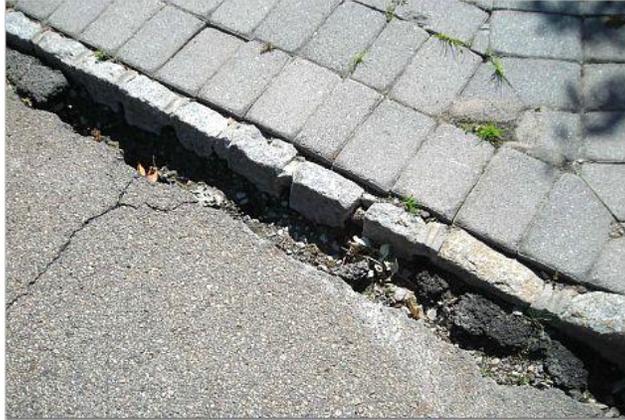
Driveway Condition: The driveway itself is generally functional, **however gaps and settlement are present at driveway entrances.**

Gap at driveway entrance

- **Have gaps and settled areas at driveway entrances repaired.**

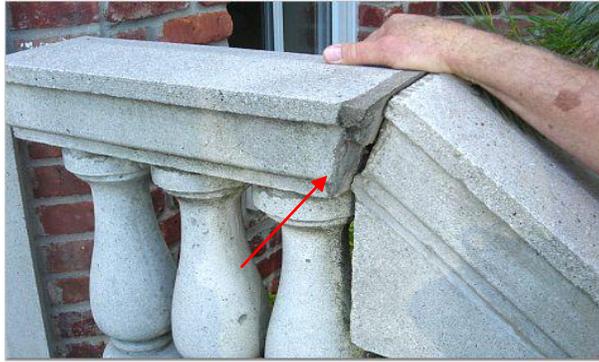
Front Entry Area: Masonry steps with stone or masonry handrails. The steps are in functional condition. **The stone handrails on both sides of the front entry steps (at the top) are not secured properly, loose, and in danger of toppling over.**

The stone handrails are not secured properly and loose

- **Have a mason properly anchor and secure safety handrails at the front steps.**
- **Have the front entry threshold repainted.**
- **Ensure the basement entry area drain is kept clear.**

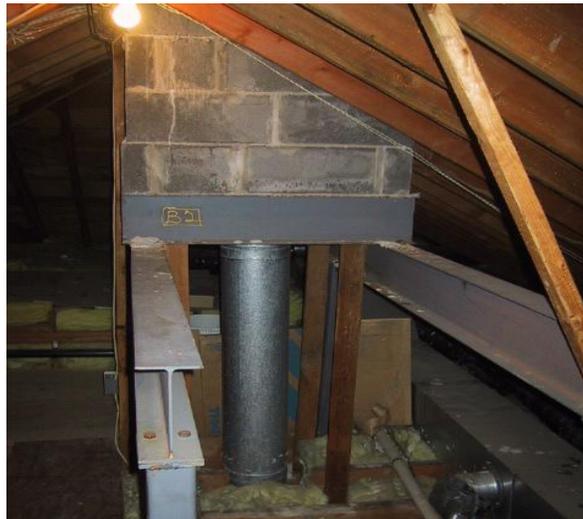
Masonry Chimneys Multiple chimneys are present on this home. Chimneys exteriors are brick masonry, and the interior flues appear to be galvanized steel flue pipe. The central chimney which passes through the roof structure is supported in the attic space by steel beams.

Support Structure for Central Chimney – note steel supports and metal interior flue pipe

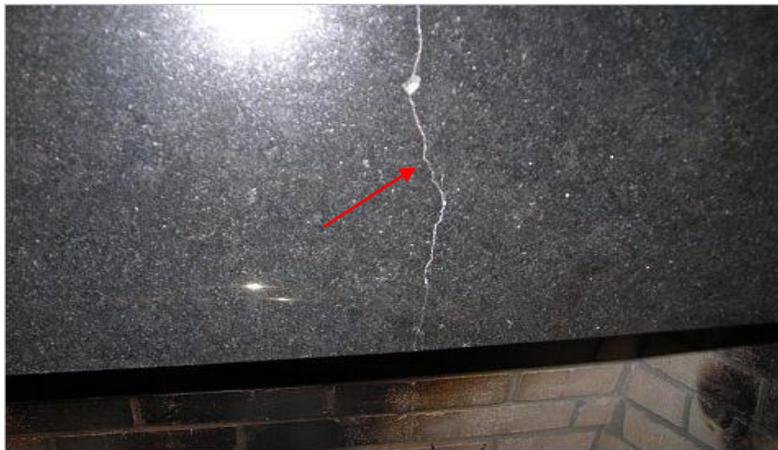
Hearth area Conditions: Functional, **with the exception of a cracked section of mantel stone on the family room fireplace.**

Crack on mantel piece family room fireplace

- **Have the cracked mantel section in the family room repaired.**
- **Have a qualified chimney / fireplace contractor clean the fireplaces and chimney flues.**

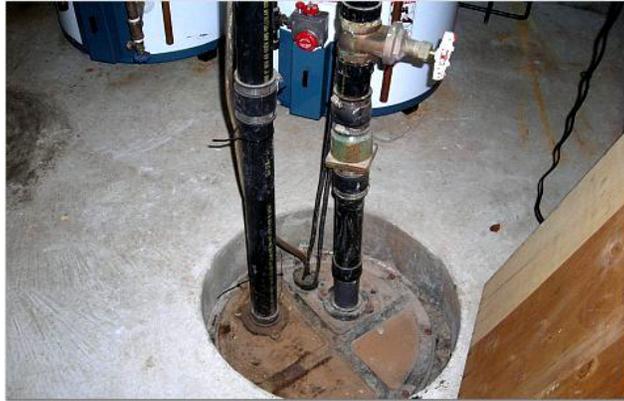
ejection pump was found to be functional on the date of inspection.

Sewage Ejection Pump in Basement Floor

Sewage ejection pumps need periodic service and preventive maintenance if trouble free reliable operation is to be assured. We recommend that this maintenance be done on a yearly schedule.

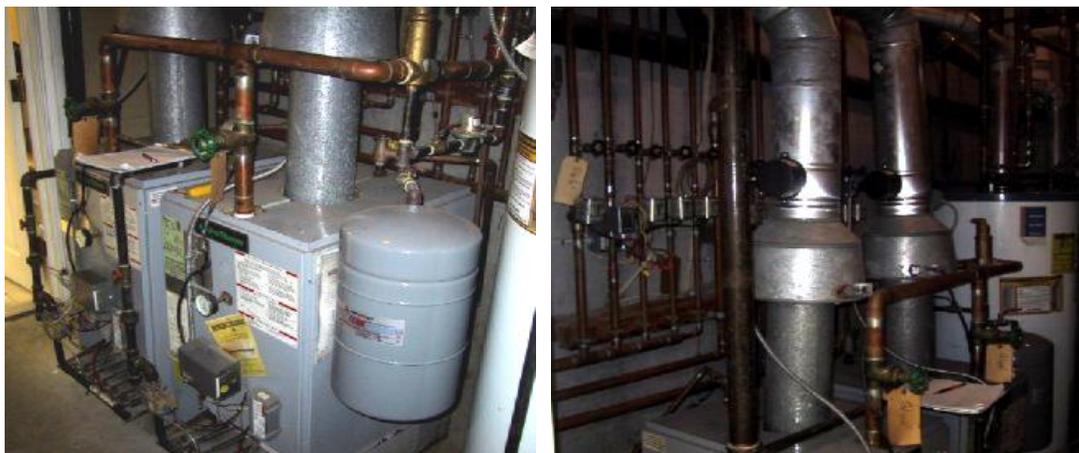
Boiler exhaust is vented by metal flue pipe to a metal chimney vent which passes through a chase and exits the roof surrounded by brick masonry. Venting components were installed in a workmanlike manner and appeared to be functional.

View of Hydronic Boilers and Multiple Zone Connections

- **The heating system in this home is complex. Complex systems need more maintenance than simple systems. We recommend that you obtain a service contract from a qualified heating contractor experienced with these complex systems.**
- **Monitor radiators and pipe connections for leakage, and have any leaks repaired promptly if they occur.**

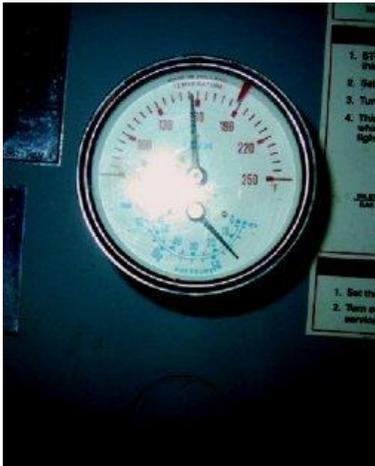
The pressure /temperature gauges installed on the boilers read approximately 15 psi and 160 deg. F. on the date of inspection, which is within the normal range for this equipment. The pressure reading further suggests that the system does not have any significant leaks at this time.

Press/Temp Gauge Reads Normal (both units)

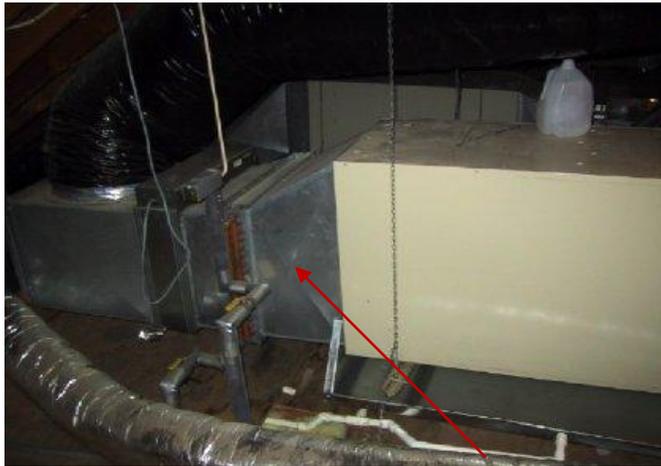
One Hydronic zone circulates hot water to a water-to-air exchanger in the Attic

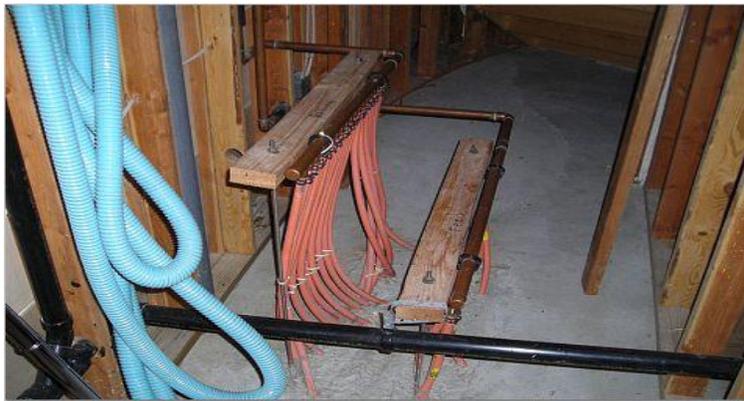
View of one Manifold and Connections to In-Slab Hydronic Radiant Heat

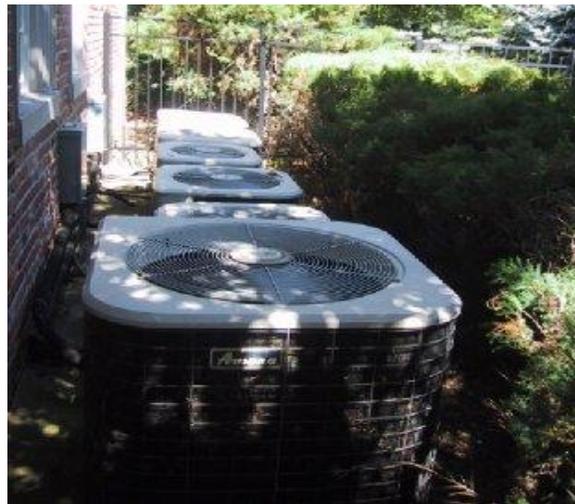
The age of the air conditioning equipment appears to be approximately 12 years. The typical service life for equipment of this type is 12 to 20 years, although failure and the need for service can occur before this time.

View of Exterior AC Equipment (6 units)

- **Yearly tune-up and service of the air conditioning systems.**
- **Budget for the need for replacement of the compressor/condenser units, which is now more likely to be needed due to the age of the units.**
