May 19, 2009

HOME INSPECTION REPORT
Street Address Removed
Short Hills, NJ

Home in Short Hills, NJ

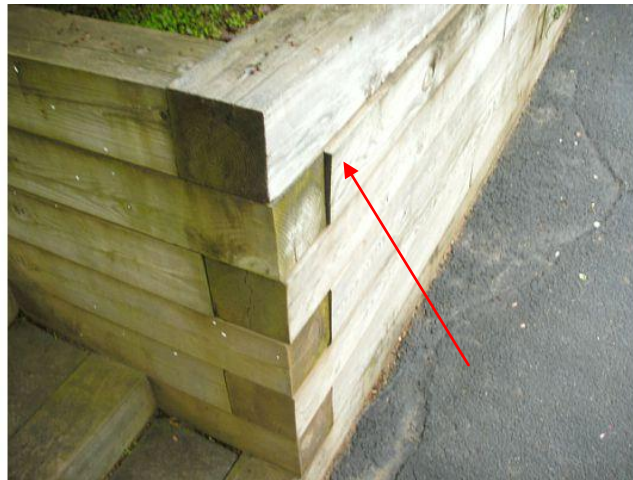
- The driveway surfaces, while currently functional, **have significant wear. The circular front driveway surface has a higher degree of wear than the side driveway.**
- **The retaining wall is currently functional, however several sections of the wood tie wall near stairs have begun to pull out of position.**

Some displacement of wood tie retaining wall

- **Have the driveway surface re-paved as desired.**
- **Have a qualified landscaper or other contractor familiar with wood tie retaining walls modify the driveway retaining wall as necessary to reduce the rate of displacement of the ties. Be aware that all wood tie retaining walls wear over time and require eventual replacement.**
- **Have worn or chipped / cracked sections of paths repaired / maintained as necessary.**

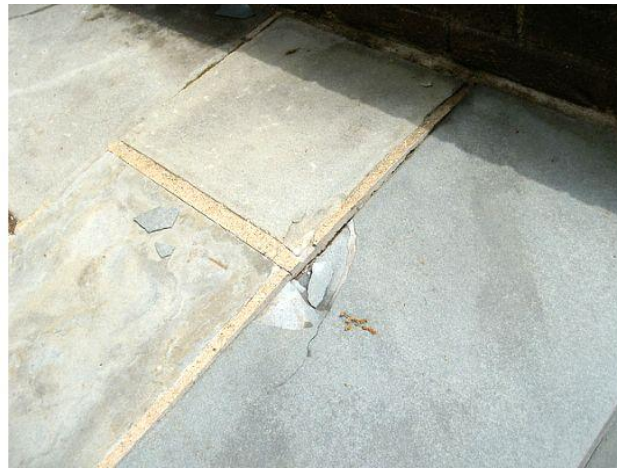
Path Condition: **Some stones are settled, chipping or cracking.**

Path wear

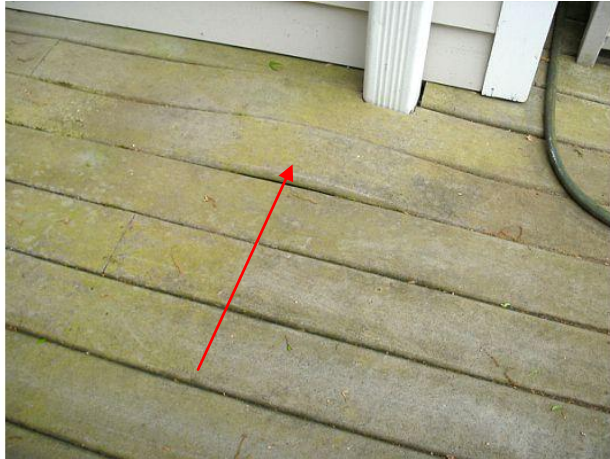
Surface Condition: **Significant surface wear, with some significantly warped deck boards. The deck boards appear to have been incorrectly installed. No space has been left between deck boards, which does not allow water from draining through deck boards and off the deck surface. This has contributed to deck surface wear and deck board warping.**

Tightly set and warped composition deck boards

- **Have a qualified contractor familiar with modern deck construction techniques further evaluate and repair / modify the deck as necessary. This may include providing drainage through deck boards, however wear and warping are significant in many areas, and deck board replacement may be required.**

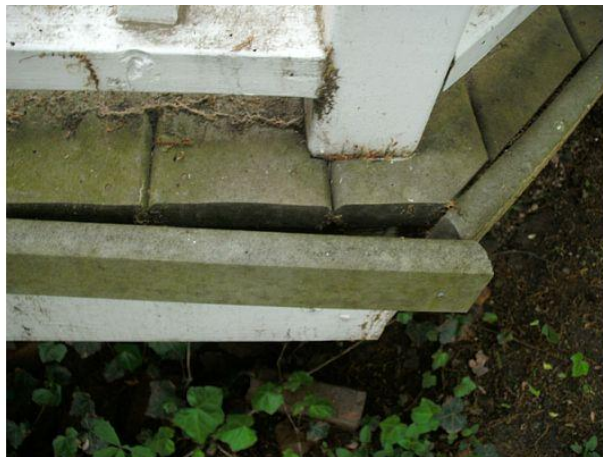
Railing Condition: The railing was tested, and was found to be sound on the date of inspection, **however some wear is present, including detaching perimeter trim boards.**

Detaching perimeter board

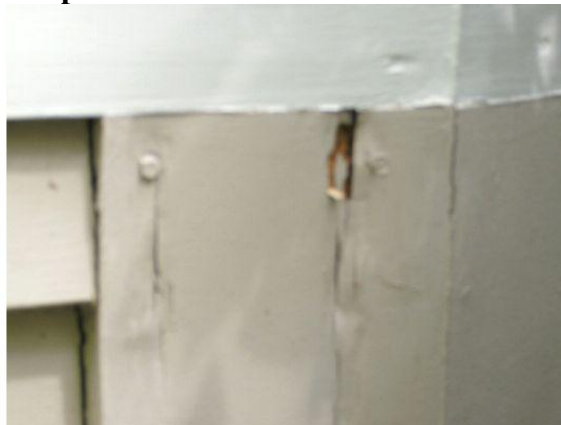
- Generally functional in most areas.
- **Some trim on bay window extensions at the front has deteriorated from water / weather exposure.**

Water damaged bay window trim

- **Have a qualified contractor repair / replace damaged wood trim as necessary. Where possible, have water / weather resistant material such as cedar or synthetic trim board used as appropriate.**

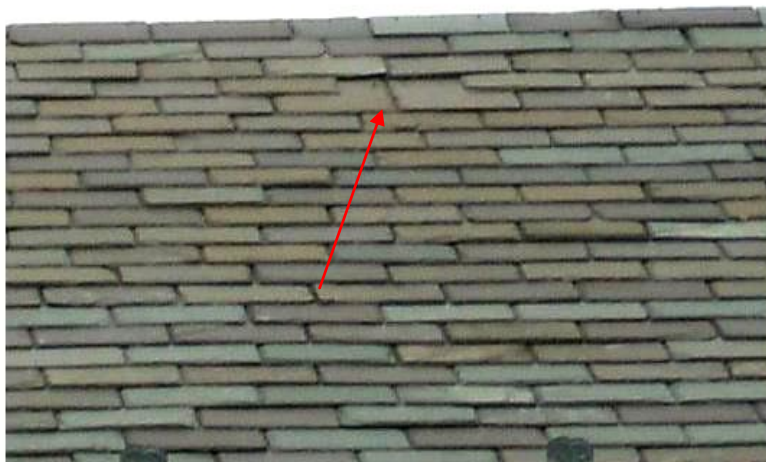
- Significant portions of the roofs are covered with slate shingles, which are installed over a wood roof deck. Slate is a natural material that is quarried sedimentary rock, and the quality can vary greatly. A service life of 60 to 100 years is not uncommon for good quality slate roofs. **The slate sections of roof are now approximately 55 years old, and are now nearing the end of service life. Some slates have cracked, missing, and have spalled or delaminated surfaces.** The roof has had some maintenance to replace damaged slates, however additional repairs and replacement of slates is now needed to assure a leak-free condition. Slate roofs in this condition can usually be maintained in serviceable condition by yearly maintenance, but this cannot be done indefinitely. The decision as to whether a slate roof should be replaced depends on the cost of yearly maintenance versus the cost of roof replacement amortized over the life of a new roof.

Example of Missing roofing slate

- **Further evaluation by a slate roof specialist to determine the true condition of the slate roof. Immediate maintenance and repairs to the slate roof to replace any cracked, slipped, and badly spalled slates is needed, and other repairs may be found to be needed following the specialist evaluation. Consult with the slate specialist with regard to the cost of yearly maintenance versus the cost of replacement of this roof. Slate roofing work is expensive, and slate roof replacement, if found to be advisable, is very expensive, and therefore you should not fail to have this roofing evaluation done before closing on this property.**

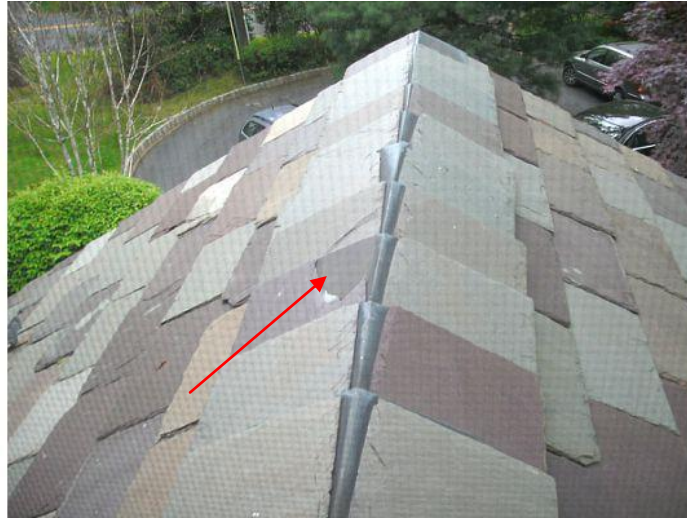
- Several of the synthetic plastic shingles appear to have cracked.

Cracked roofing

- **Further evaluation and repairs as necessary to any damaged sections of synthetic slates by a qualified specialty roofer familiar with this type of roof.**

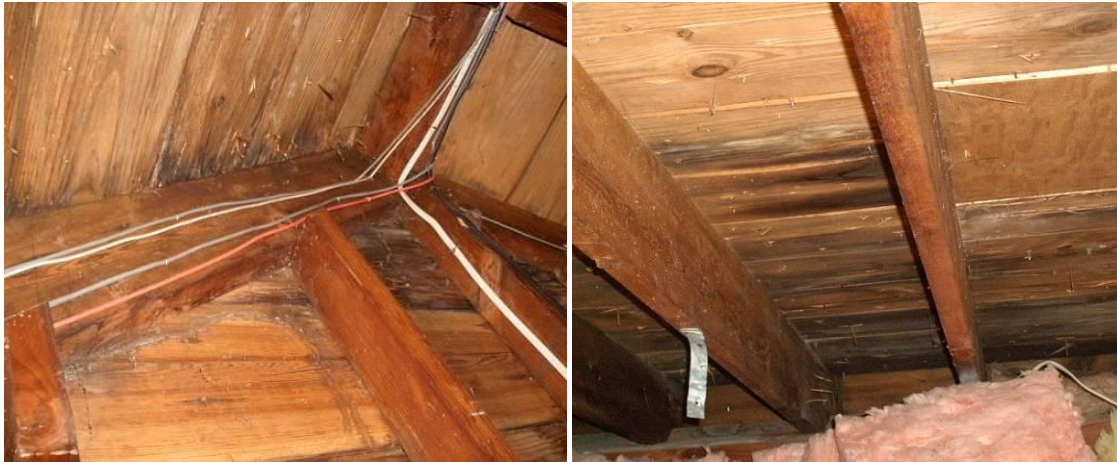
- Some roof flashings are now aging. Leakage is more likely to occur around old flashings.
- Stained areas suggesting prior leaks or moisture condensation were seen on the underside of the roof in the attic crawlspaces.

Staining on the underside of the roof / in attic suggests leakage

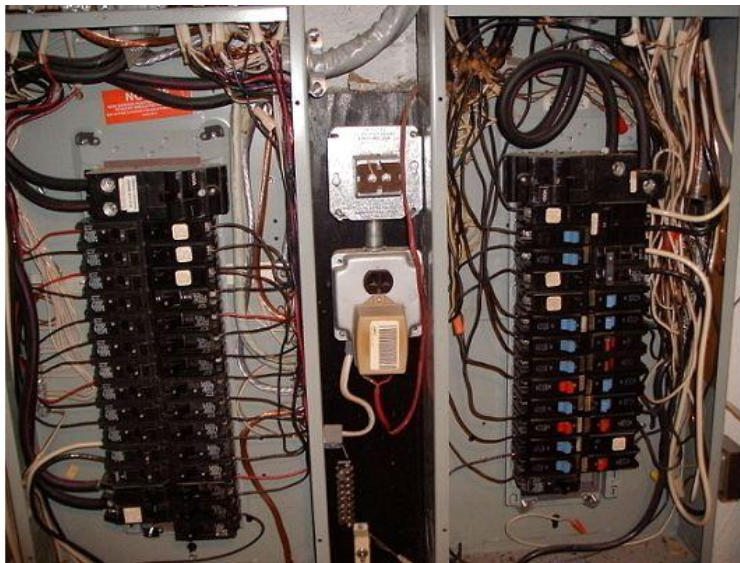
- **One double tapped circuit breaker is present in the right side main breaker panel. This is incorrect wiring technique.**
- **Both main breaker panels are almost full, with little or no additional space for expansion.**

The main breaker panels

- **A 125 amp feed for a subpanel or other device is present in the left side panel. The addition of this heavy load in this otherwise full panel may now render this service equipment overloaded.**

- **Have a licensed electrician eliminate the double tapped condition in the circuit breaker panel.**
- **Have a licensed electrician install functional GFCI electrical receptacles in all wet areas of the home including kitchens and bathrooms that lack them.**
- **Have a licensed electrician further evaluate the breaker panels and make repairs or modifications as necessary to ensure a safe and compliant condition, and that adequate capacity is present and adequately distributed.**

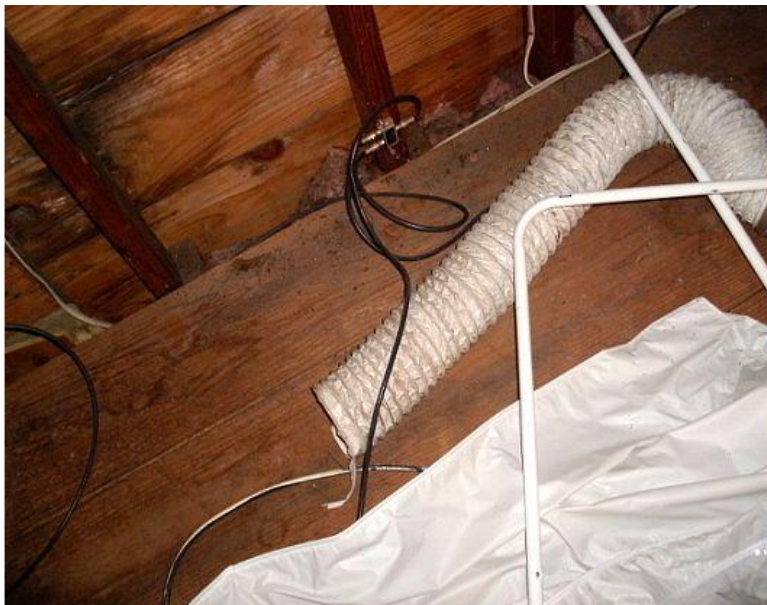
- **Roof / attic ventilation does not appear to be adequate (see Roof section).**
- **Some bathroom vent fans appear to discharge directly into attic space, contributing to high moisture conditions in the attic.**

Bathroom vent fan discharge hose

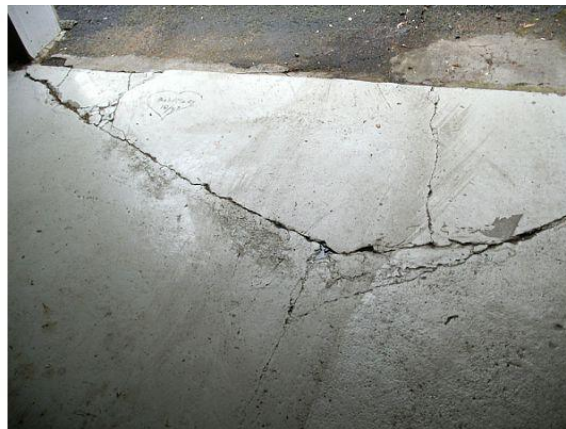
- **Some cracks and settlement, particularly at garage door entry areas.**

Cracked garage floor slab

- **Have the garage door opener(s) lacking adequate electric eye safety cutoff sensors replaced with new approved equipment. This work should be done by a qualified garage door contractor.**
- **Have the cracked areas of the garage floor slab repaired.**
- **Ensure that the floor drain remains clear and free flowing.**
