MHI Services, Inc. - Licensed Home Inspectors

April 23, 2008

HOME INSPECTION REPORT

XXXX Avenue
South Orange, NJ

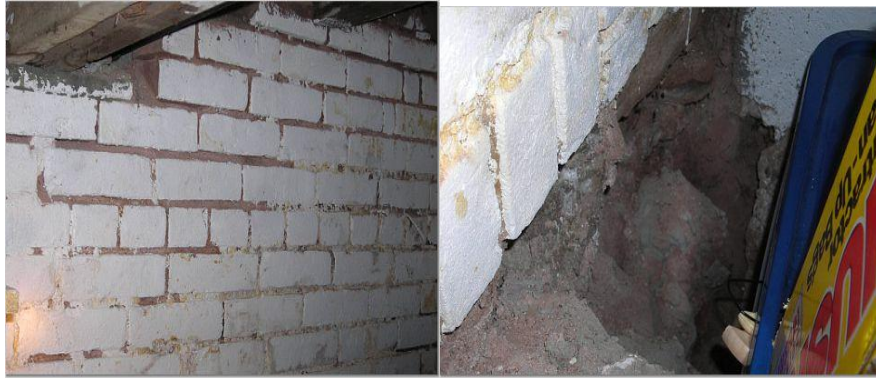
- **Cement mortar at some areas of the foundation are deteriorated, or missing. This is a result of advanced age and lack of maintenance to the masonry foundation. Some sections of stone on the intermediate stone wall (at the rear of the original foundation section) are loose. Deteriorated mortar and loose stone in walls, if not repaired, will eventually result in foundation wall failure or structural settlement.**

Deteriorated mortar and loose stone in foundation

- **Have a qualified mason re-point loose sections of mortar in walls and brick columns, and repair any loose stone.**
- **Have a qualified contractor reinforce any older mortise and tenon joints with framing brackets or other acceptable methods.**

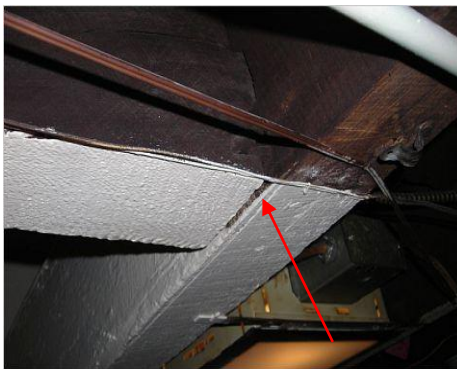
- **Older floor framing around the stairwell is attached using mortise and tenon joints. Several of these joints are now beginning to pull away, leaving gaps between the joists.**
- **One joist is developing a crack at the mortise joint.**

Mortise and tenon joint with gap

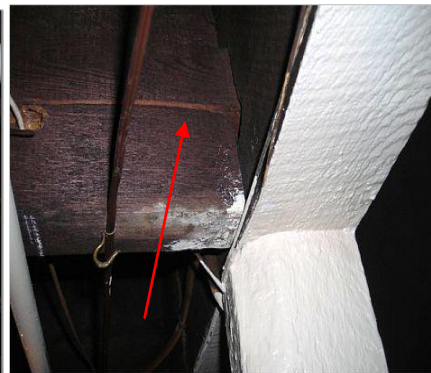
Joist cracked at tenon joint

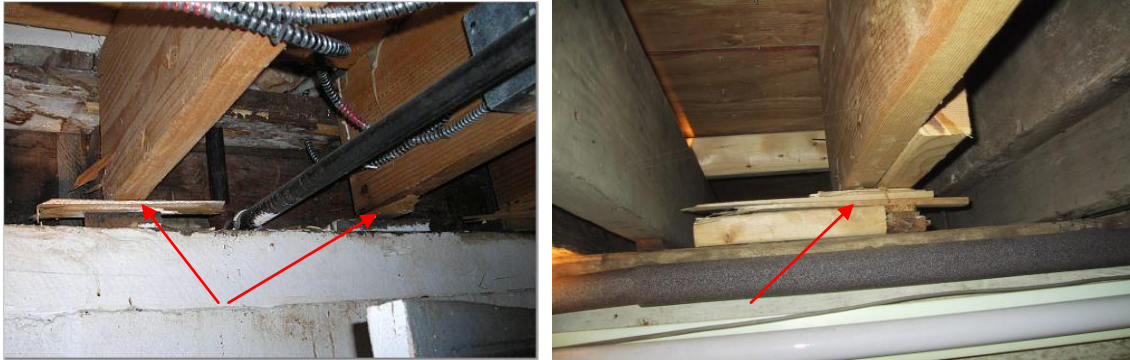
- **Most sections of main beams are smaller section than called for by modern construction standards, and may not have adequate stiffness to prevent deflection and settlement of the flooring over time.**
- **The flooring at the rear section of the home has been raised and/or leveled,**

using newer lumber in parallel with older lumber, and elevated off the foundation walls and main beams with blocks of wood and shims. The shims are extremely haphazard, some shims are loose, and many areas of these shims are made of scrap wood, which may compress over time. The flooring is not professionally built, and will likely settle and sag over time unless this issue is addressed.

Random scraps and shims support joists in rear section of the home

- **Have a qualified contractor properly rebuild or modify the rear section of raised floor framing so that it remains structurally sound over the long term.**

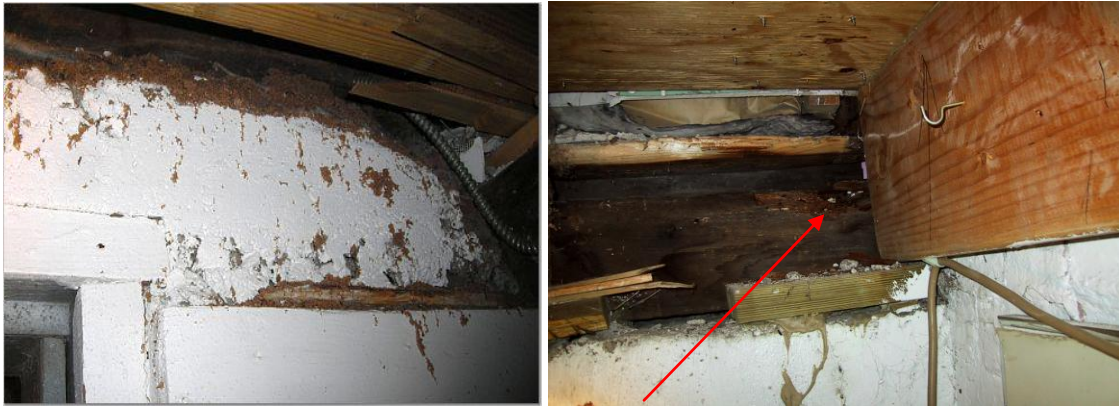
- Some termite damage is present to framing at the right front corner.
- A significant amount of carpenter ant activity was found at the left rear of the basement, and an old sill plate has been damaged by what appears to be wood destroying insect activity.

Significant carpenter ant frass, and damage to old sill plate at left rear

- **See the separate wood destroying insect report from Terminite, Inc. for more information relating to the wood framing of this home. If evidence of wood destroying insect infestation is found, then be aware that further evaluation would be required to assure that hidden damage to structural members is not present.**

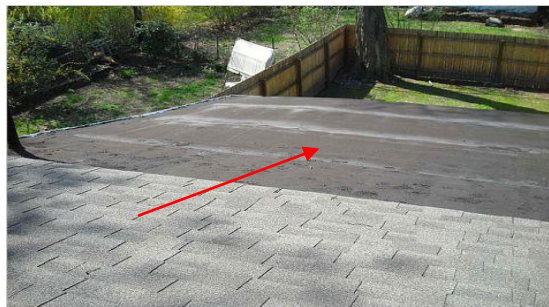
- Roof shingles appeared to be serviceable on the date of inspection.
- **Some roof flashings may be older than the currently installed roof. Leakage can occur around old flashings.**
- **No protective roofing paint is present on the rear low sloped roof. This will result in accelerated roof surface wear.**

Rear low sloped roof has no protective paint

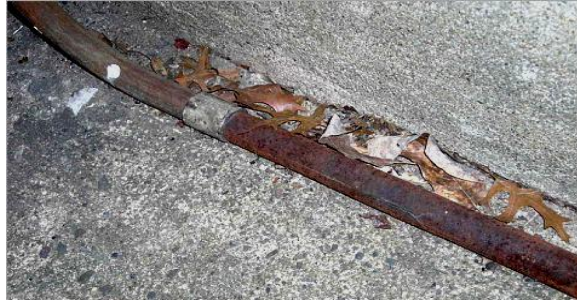
- **A section of exterior metal electrical conduit has been damaged by exposure to water from mis-directed downspouts.**

Corroded electrical conduit

- **Have a licensed electrician install functional GFCI electrical receptacles in all wet areas of the home including kitchens and bathrooms that lack them.**
- **Have a licensed electrician evaluate the home with regard to knob & tube wiring. If present, you may wish to have such wiring disabled and/or removed.**
- **Have the corroded electrical conduit replaced.**

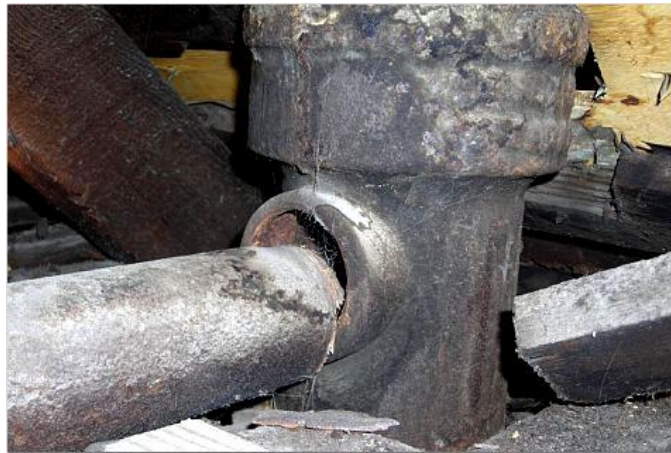
- **Visible sections of iron drain pipe are aging, and many sections in the basement have been painted. This could obscure areas of corrosion or past leakage.**
- **One section of iron vent pipe in the attic has detached from a main vent stack. This may allow sewer gases to accumulate in the attic.**

Drain Vent pipe in attic disconnected from stack

- **Have a plumber evaluate the main water shutoff valve and repair or replace it as necessary to assure reliable function.**
- **Have a plumber replace any remaining sections of iron water supply pipe.**
- **Have a plumber replace any older water supply shutoff valves with corrosion or leakage.**
- **Have a plumber repair the detached drain vent pipe section in the attic.**
- **To determine the true condition of the waste and drain pipes we recommend that a plumber inspect them internally using a specialized video camera.**

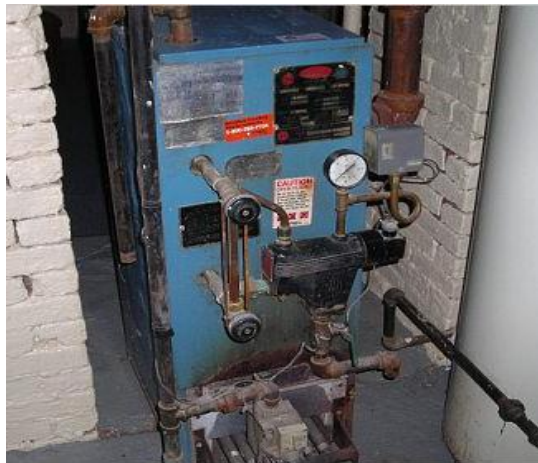
- **The heating system is past the end of its designed service life. Continued safe and reliable operation cannot be assured.**
- **Significant scorching and rust are present on the heating system case, which suggests hidden defects.**

Aging heating system with corrosion and scorching

- Due to the age and condition of the boiler we recommend replacement at this time. If you choose not to have this boiler replaced at this time, then we strongly recommend that a heating specialist or plumber disassemble the case and inspect the internal components to assure that hidden defects that may affect safety and function are not present. Regardless of your choice, remaining service life on this boiler will be limited, and replacement will be needed in the near future.
- Monitor radiators and radiator connections for leakage, and have any leaks repaired promptly.
- See Chimney section.

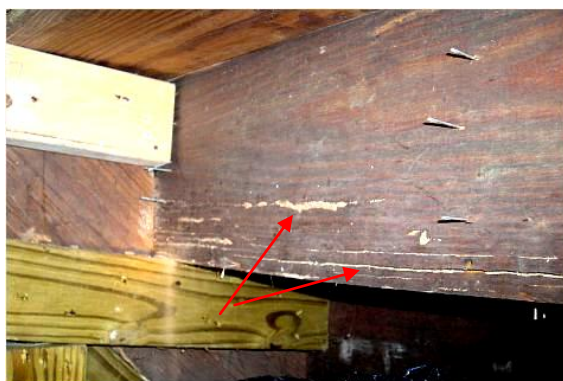
Interior Stairs Stairs from the first floor to the second floor are functional. **Basement stairs have sustained damage from a wood destroying insect infestation (termites).**

Termite mud tubes are present beneath basement stairs

- **Have a qualified contractor repair / replace termite damaged sections of basement stairs.**
- **See separate wood destroying insects report from Terminite, Inc.**

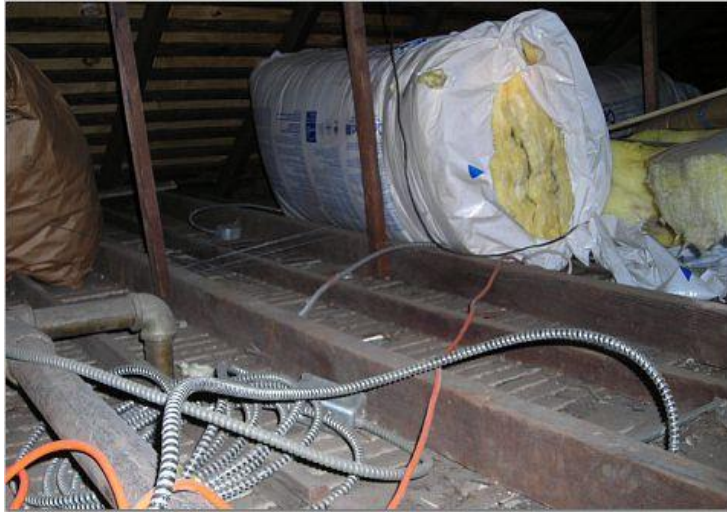
- **Little or no installed insulation appears to be present. Insulation in the attic has not been installed.**

Insulation is not installed

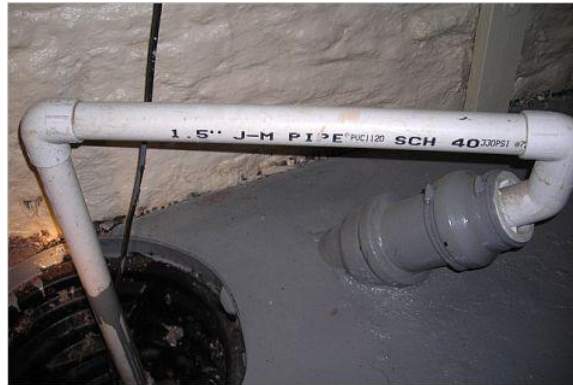
- The sump was dry on the date of inspection.
- The pump was briefly tested by lifting the float, and did activate.
- **The sump pump discharges directly into the house plumbing drain system. This may not be permitted by local regulation.**

Sump pump discharging directly into plumbing drainage system

- **See Roof Drainage section – proper maintenance of gutters and downspouts can reduce the possibility of water entry into the basement.**
- **Have a plumber modify the sump pump discharge so it discharges to the exterior, directed away from the foundation of the home.**
