May 26, 2009

**HOME INSPECTION REPORT**

**Address Removed**

**South Orange, NJ**

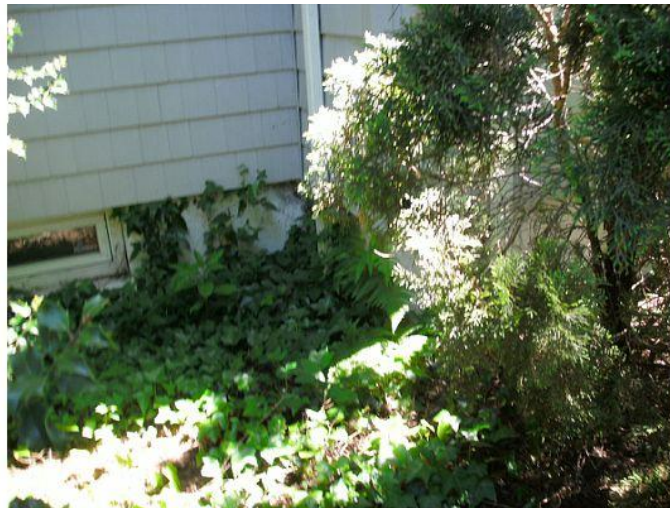
- **Overgrown vegetation is close to or in contact with the sides of the house in some areas. This is conducive to wood destroying insect entry.**

Overgrown vegetation in contact with home

- **Have trees, shrubs and plants trimmed back or removed so they are no longer in contact with the home.**

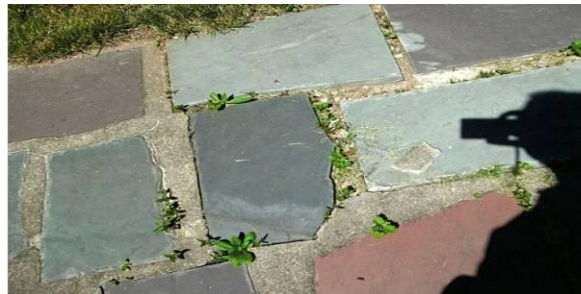
Condition: **Significant wear and cracking.**

The worn patio

- **Have the patio repaired or replaced as desired.**

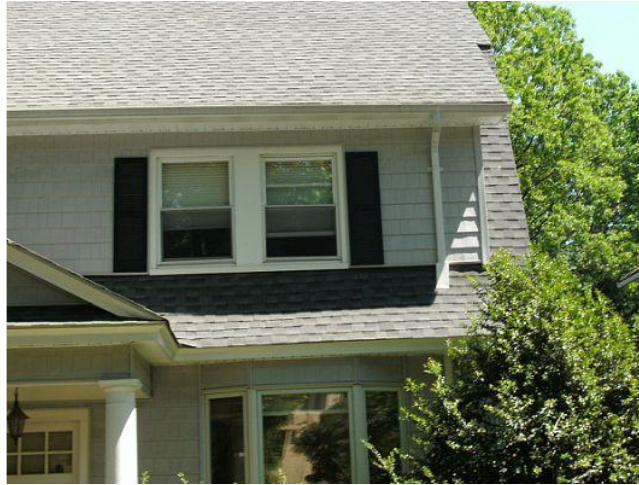
- **No gutters are present on the lower front edge of the home. This could allow significant amounts of water to accumulate at the base of the home.**

No gutters on lower section of roof

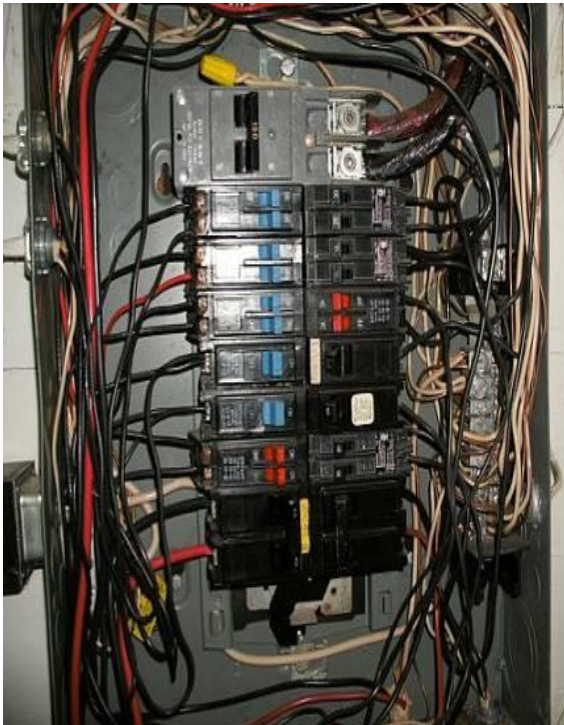
- **The circuit breaker panel (main service panel) is overfull and crowded, and this is considered to be poor practice and may result in malfunction.**
- **Two double tapped circuit breakers are present in the breaker panel. This is incorrect wiring technique.**

Crowded Main Electrical Panel

- **Have a licensed electrician eliminate the double tapped conditions in the circuit breaker panel and also determine if modification or replacement is needed to eliminate the overcrowded condition.**
- **Have a licensed electrician install functional GFCI electrical receptacles in all wet areas of the home including kitchens and bathrooms that lack them.**
- **Have a licensed electrician evaluate the home with regard to knob & tube wiring. If found to be present, it is advisable to have such wiring disabled and/or removed, with the affected circuits replaced with approved wiring.**

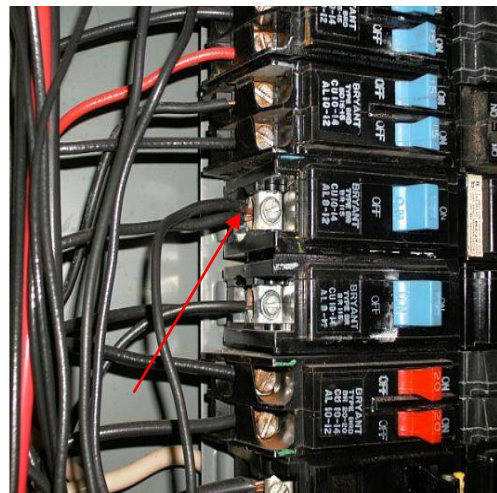
Double tapped circuit breaker

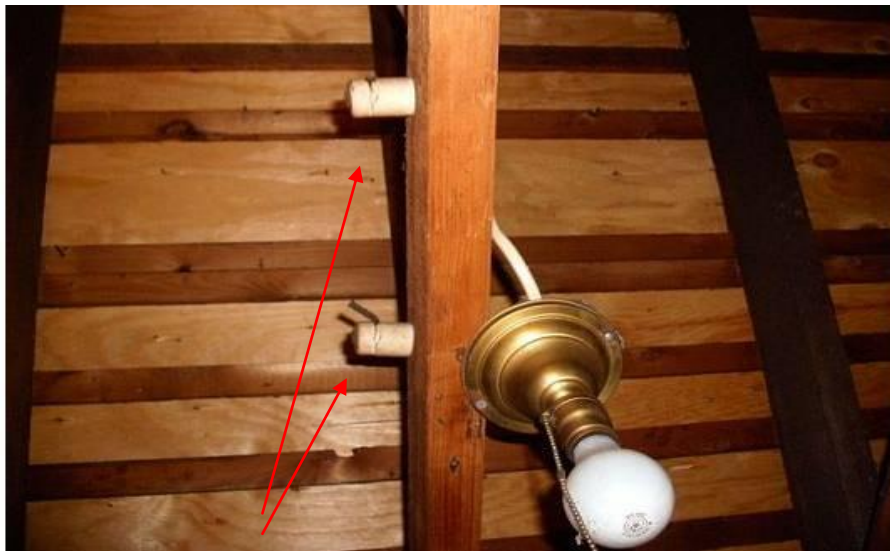
*Note 2: Homes built between the years 1910 and 1935 were sometimes wired with what is known as knob & tube branch circuits, which are no longer considered to be acceptable by most underwriting agencies. This home appears to have been built in the period when this wiring was common, and it is possible that such wiring is present within walls and ceilings. Our inspection found direct evidence that such wiring was once present, but no active circuits of this type were visible to this inspector.*

*Evidence of Removed Knob-and-Tube Wiring in Attic*

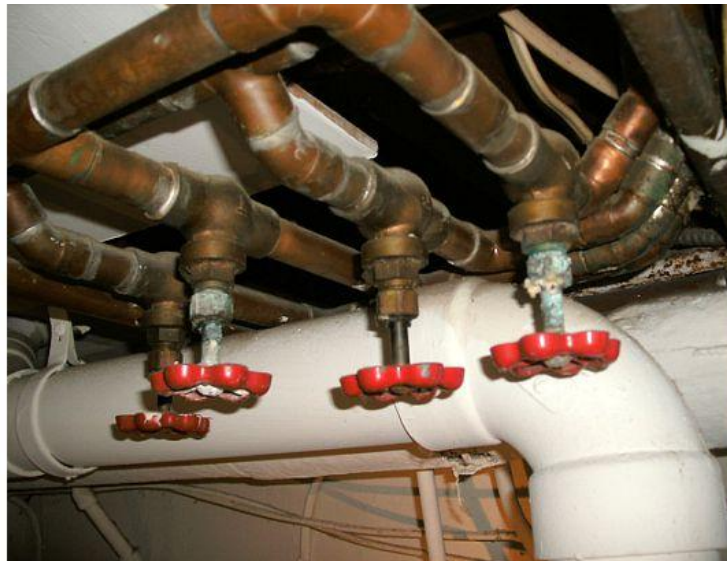
- Copper water pipe itself is functional.
- **Some older shutoff valves have significant corrosion and signs of leakage.**

Corroded shutoff valves

- **Have a plumber replace any older water supply shutoff valves with corrosion or leakage.**
- **Have a plumber inspect the plumbing vent stack and connection that appears to be tilted (on the roof), and repair as may be found to be needed.**

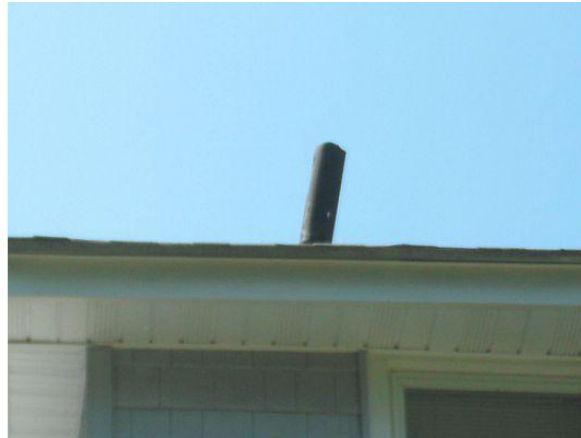
- Drainage appeared to be functional on the date of inspection, as determined by a limited operation of multiple plumbing fixtures.
- **Some sections of older iron drain piping have visible signs of corrosion.**
- **A section of plumbing vent above the roofline visible at the rear appeared to be tilted.**

Tilted plumbing vent stack

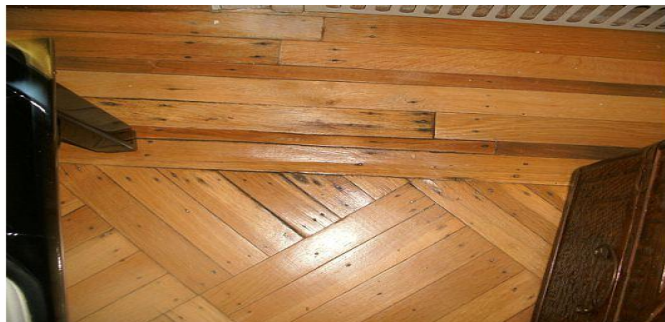
- **Wood flooring is blackened around a radiator in the living room, possibly from prior radiator leakage.**
- **Some sections of wood flooring in the front entry area are loose. Wood finish flooring is worn thin in some areas.**

Worn Finish Flooring

- **Have worn and loose sections of flooring repaired and refinished as necessary.**
- **Have cracked bathroom floor tile replaced.**

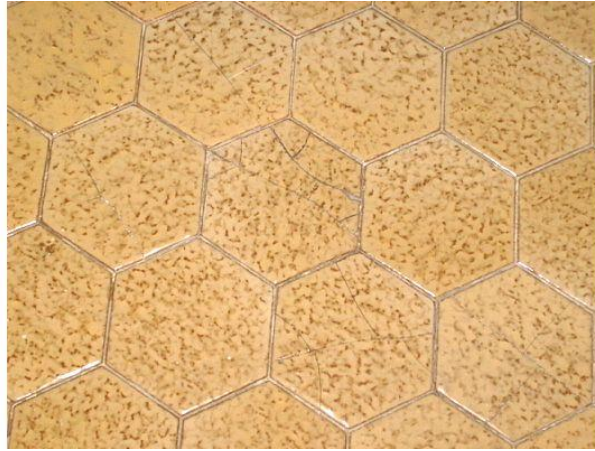
- **Floor tile in the second floor bathroom is cracked.**

Cracked floor tile

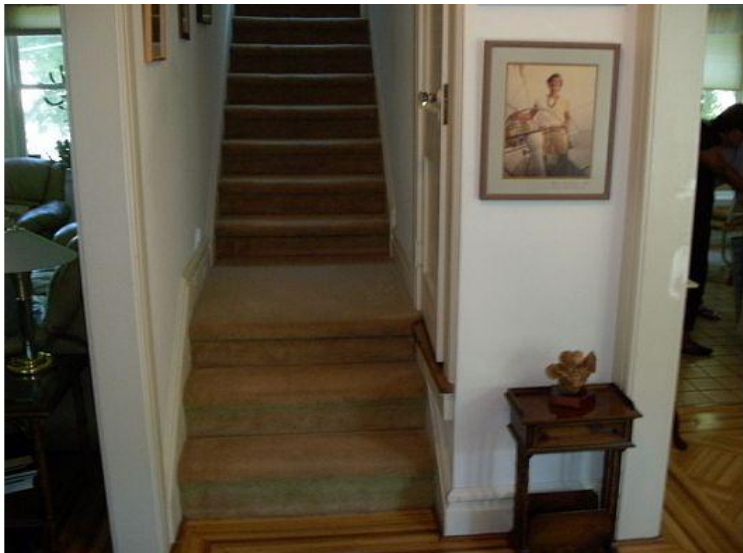
Interior Stairs No hand rail is present along some sections of the main stairs. This is a falling hazard.

The main stairs, with no handrail present

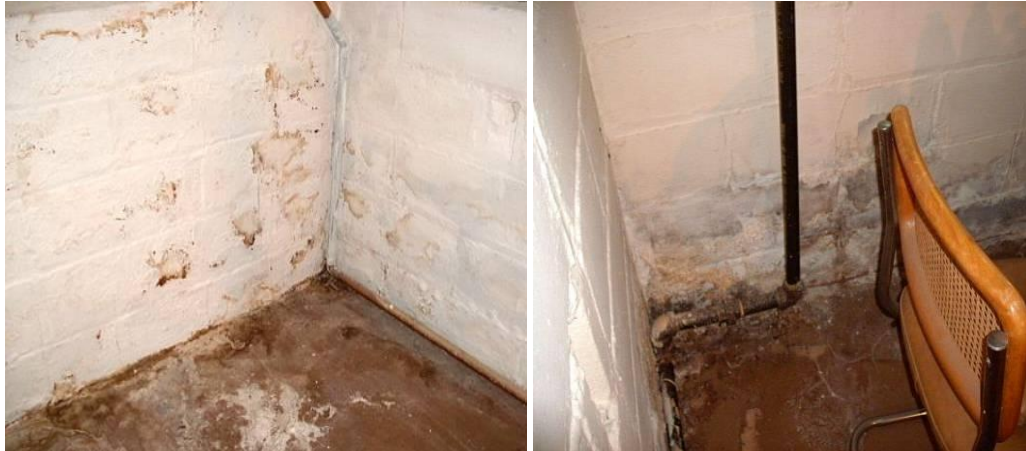
- **Signs of prior water entry were found to be present on foundation walls and the floor in the basement. Significant water staining was present on foundation walls at the front of the home, which suggests a problem in need of correction.**
- **Lack of maintenance to the roof drain system could be contributing to water**

**entry into the basement.**

Evidence of Water Penetration of the Foundation Walls seen in Basement

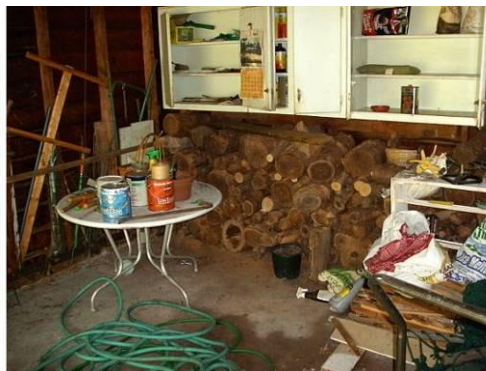
- **Significant quantities of firewood are being stored in the garage, along the garage walls. This is conducive to wood destroying insect entry.**

Firewood piled in the garage

- **Have firewood removed from the garage.**
- **See separate wood destroying insects report from Terminite, Inc.**
- **Further evaluation of insect damage in the garage, with repairs of any damage found. This work should be done by a qualified contractor familiar with wood destroying insect damage repair.**

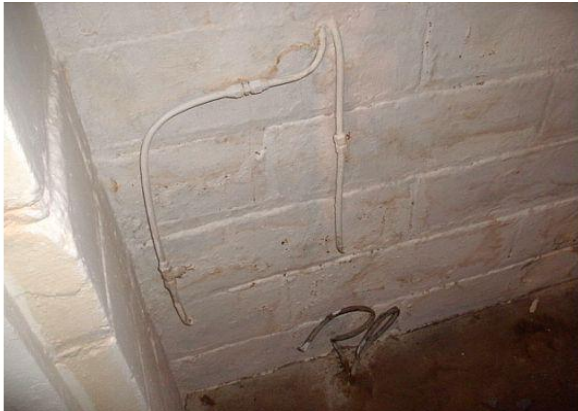
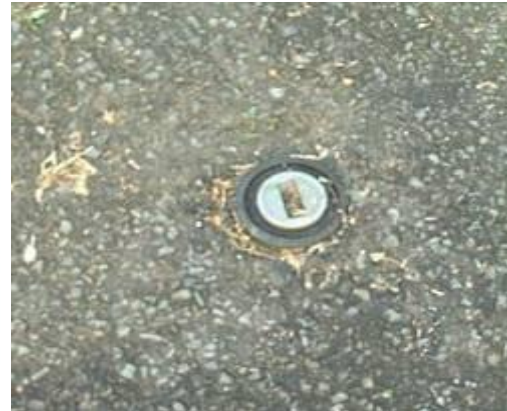
The heating system for this home uses natural gas. **Prior heating systems did use oil. Evidence was found that an old buried oil tank is present or was present buried underground in the front.** Buried oil storage tanks corrode and become defective over time, and may leak oil into the ground creating an environmental hazard.

Old oil lines and an oil fill in the driveway indicate presence of an abandoned buried oil tank

- **Specialist search for abandoned buried tanks and specialist evaluation of buried and/or above ground oil storage tanks, either in use or abandoned. As leaking oil tanks can result in significant expenses, we advise careful review with legal counsel of any documents or statements relating to oil tank(s).**
