July 29, 2008

HOME INSPECTION REPORT

Address Removed

Summit, NJ

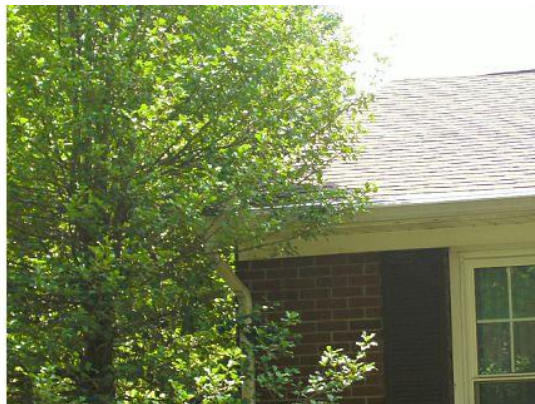
- **Overgrown vegetation in close to or in contact with the sides of the house in some areas.**
- **Trees or tree branches adversely impacting the home.**

Tree in contact with the home

- **Have trees, shrubs and plants trimmed back or removed so they are no longer in contact with the home.**

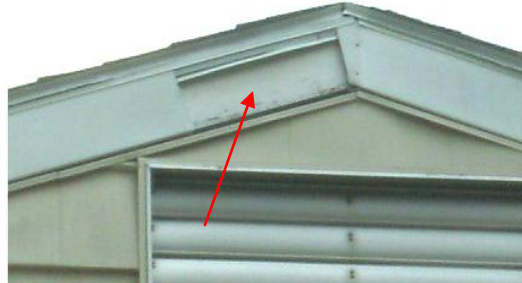
- Generally functional in most areas.
- **A section of roof edge rake board trim on the right side is missing.**

Missing roof edge trim

- **Have aluminum siding at the rear replaced along with back porch renovations.**
- **Have missing section of trim replaced.**
- **Have any bent sections of trim replaced.**

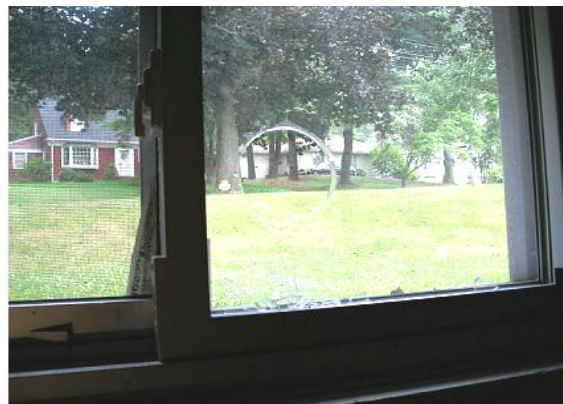
- Most windows were found to be in functional condition on the date of inspection.
- **One basement window has broken glass.**

Broken glass at basement window

- **Have broken basement window replaced.**
- **Installation if necessary and use of window guards on all windows above the first floor level.**
- **Have windows in the rear enclosed porch replaced as part of a general renovation of this room.**

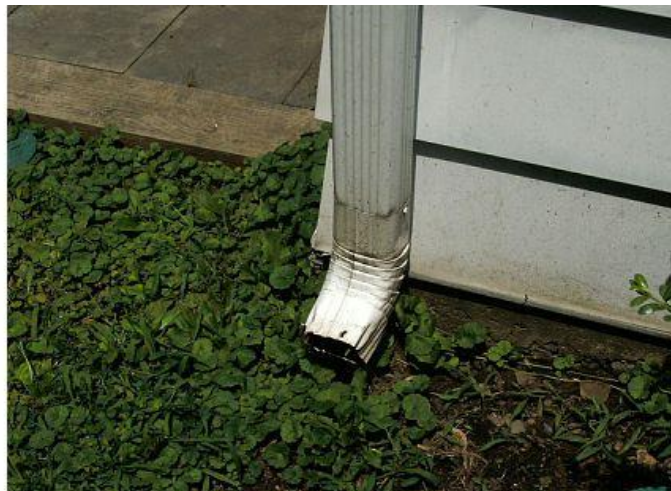
- **A number of downspouts discharge too close to the base of the home.**

Downspout at base of home

- **In particular, a downspout at the left front discharges directly at the base of the home. This appears to be causing or contributing to water entry into the basement.**
- **Some gutters appear to be clogged.**

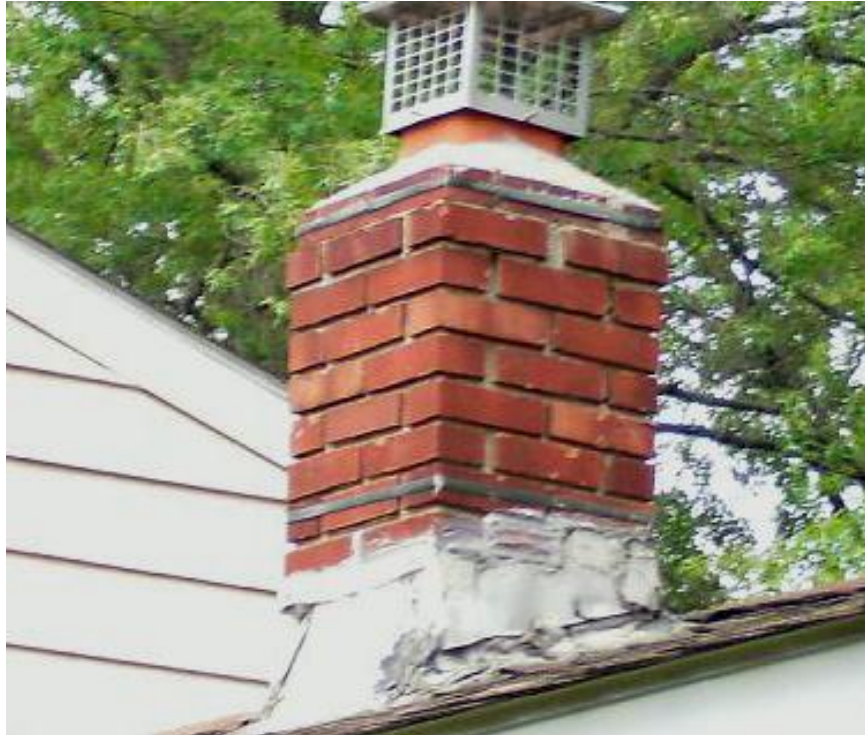
Chimney needs maintenance

- **Chimney flashings appear to be older, and improperly patched. Leakage can occur around older or improperly patched chimney flashings.**
- **Some cracks, loose and missing sections of mortar were seen on the upper sections of the chimney.**

- **The National Fire Protection Association and the National Chimney Sweep Guild recommend that, due to the advanced age or other conditions, a Level-2 Inspection of the chimney and internal components be done to rule out hidden potential safety defects.**
- **Have a qualified chimney contractor service or repair the chimney(s) as required to assure long term function and safety.**

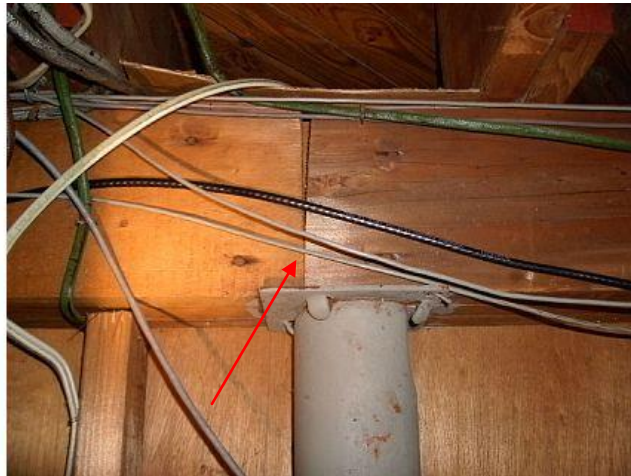
- Generally functional condition where visible.
- **One support column is not properly located under a joint in the main beam. This could result in structural settlement.**

Column not completely centered beneath beam joint

- **See Roof Drainage section – make sure water around the home is well controlled, with no accumulation near the base of the home. This can help reduce the possibility of foundation settlement and water entry in the future.**
- **Evidence of wood destroying insect activity was found as documented by the separate wood destroying insect inspection. See the separate wood destroying insect report from Terminite, Inc. for more information relating to the wood framing of this home. Since evidence of wood destroying insect infestation was found, further evaluation is required to assure that hidden damage to structural members is not present.**
- **Monitor the main beam joint that is not fully over the column over time for any signs of movement. If any such movement occurs, installation of an additional column below this main beam joint may be advisable.**
- **See Roof section.**

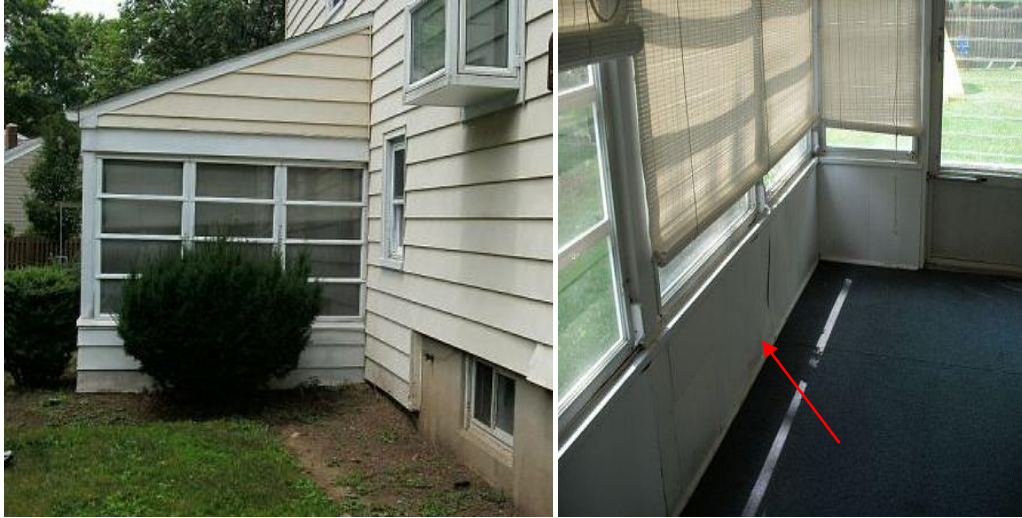
- Walls for the rear enclosed room are in poor condition and there may be structural damage resulting from water entry in this area.

The walls for the rear attached room are damaged from water intrusion

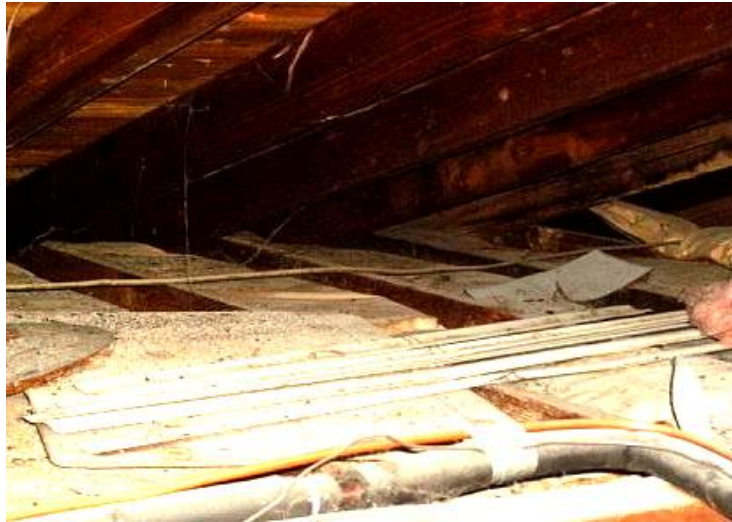
Roof ventilation is inadequate. Soffit vents are blocked by insulation pushed to

the roof edge in the attic, and the ridge vent is not fully open.

Insulation extends to the roof edge blocking ventilation, and roof sheathing boards are stained from water

Inadequate roof ventilation can lead to damage to the roof structure, reduced shingle life or mold conditions in the attic.

- **Have a qualified roofer ensure that the ridge vent is opened – wood sheathing should not obstruct the vent near the ridge of the roof.**
- **Have insulation pulled away from the roof edge to allow more ventilation.**
- **Have a qualified roofer evaluate the roof for wear and/or leakage and make repairs or replacements as necessary. This may include replacement of some roof sheathing if deterioration is found to be excessive.**

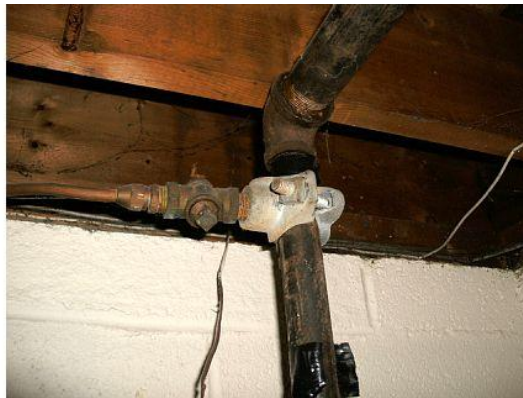
- **There is a gas line hookup, possibly for an exterior gas connection, which utilizes a pipe piercing clamp-on connector. This connection is present near the meter. This type of gas connector are prone to develop leaks.**

Clamp type gas pipe connector may develop leaks

- **Have a plumber replace the gas clamp connector with standard gas piping and threaded connections.**

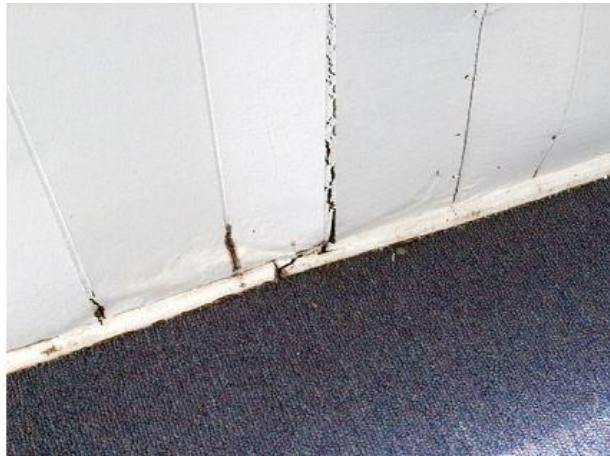
- Generally functional for the main part of the home – only minor repairable defects in most areas.
- **Lower outer walls of the rear enclosed porch are in poor condition, with evidence of water entry and water damage. Water entry may be occurring through non-weather tight windows in this area, or through poor aluminum siding at the rear, or as a result of inadequate surface drainage.**

Damage to wall in enclosed rear porch caused by water intrusion

- **Replacement of siding and / or windows along the rear enclosed porch.**
- **Be sure no water accumulation is occurring at the rear.**
- **Have the rear enclosed porch re-built or renovated as desired.**
- **See Bathrooms section.**

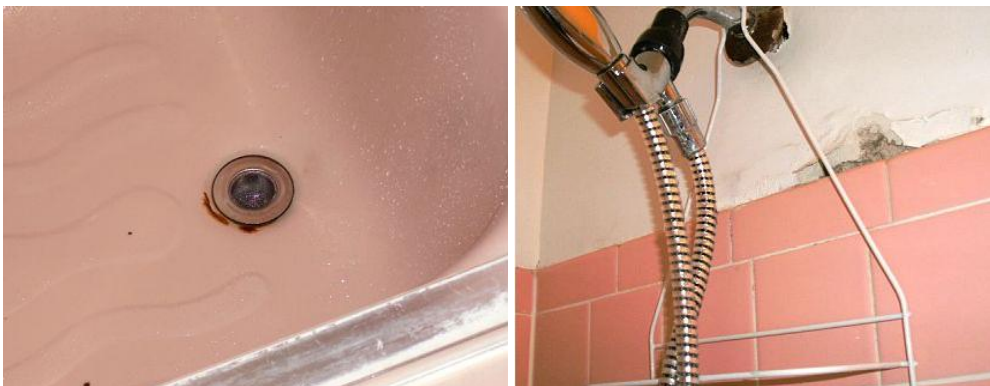
Tub drain corrosion and wall damage in bathroom

- **Fixtures and faucets in bathrooms are older.**
- **The grade level bathroom toilet does not flush properly.**
- **Floor tile in the second floor bathroom is cracked.**
- **Lower wall tile in the second floor bathroom is loose or missing in several areas.**
- **Corrosion is present around the tub drain.**
- **There is a wall is damaged just above the shower area.**

- **Have the first floor toilet adjusted so that it flushes reliably.**
- **Plan for general renovation of the bathrooms, included replacement of floor and wall tile. Be sure the sub-floor can support ceramic tile without cracking. Reinforcement may be needed.**
- **The corroded tub drain may be subject to leakage, and should be replaced.**

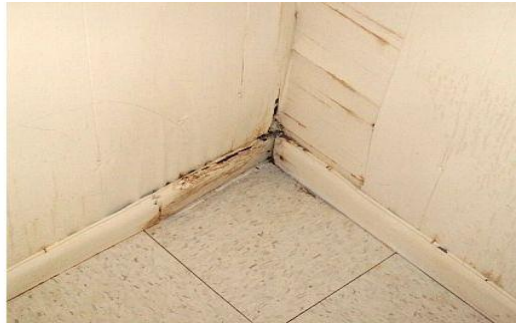
- **Signs of prior water entry were found to be present on some visible areas of foundation walls.**
- **Stains and high moisture meter readings were found at the left front corner of the home, which indicates that a current water intrusion problem exists.**

This area of basement wall tested wet

- **Lack of maintenance to the roof drain system, particularly at the left front corner, has likely contributed to water entry.**

- **See Roof Drainage section – proper maintenance of gutters and downspouts can reduce the possibility of water entry into the basement.**
- **Further evaluation by waterproofing specialists to determine what additional measures are needed to assure that this basement or crawl space remains dry, followed by installation of these waterproofing systems.**
- **Replacement of the sump pump with a new unit.**
- **Removal of interior finish material that has been damaged by water intrusion.**
- **See the section of this report discussing Mold for more information.**
