July 29, 2008

HOME INSPECTION REPORT

Address Removed

Summit, NJ

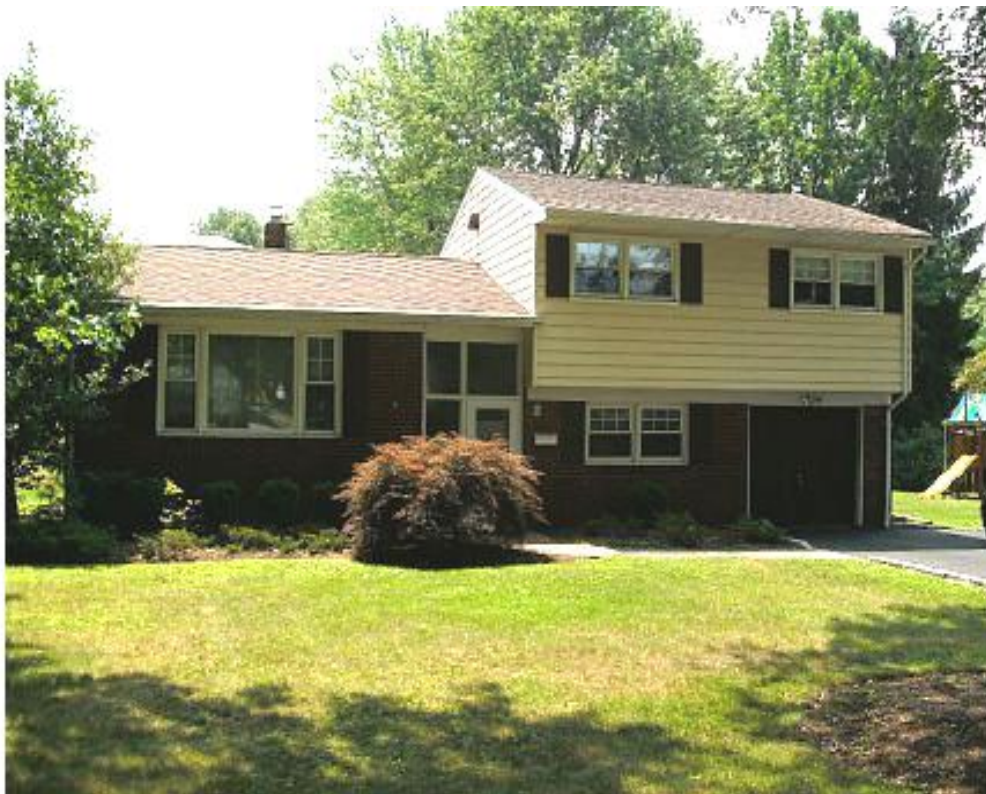
Home in Summit, NJ

Description of Property Wood frame, one family, two story, split level style home. The grade level is the entry level, with an entry hall, family room, rear enclosed porch (which is unheated) and half bathroom. The first floor has a living room, dining area and kitchen. The second floor has three bedrooms and one full bathroom. There is a partly finished basement. There is an interior one-car garage.
